**LAND SUBSIDENCE & EARTH FISSURE EVALUATION  
TASK 1 & TASK 2 EARTH FISSURE EXPLORATION PROGRAM.**

**SUNVALLEY RANCH, TRACT L, APN 218-16-023  
SWC E. BILLINGS STREET & N. SOSSAMAN ROAD  
MESA, MARICOPA COUNTY, ARIZONA**

**GCI Project No. 2017-144**

January 29, 2018  
Revised: April 7, 2018

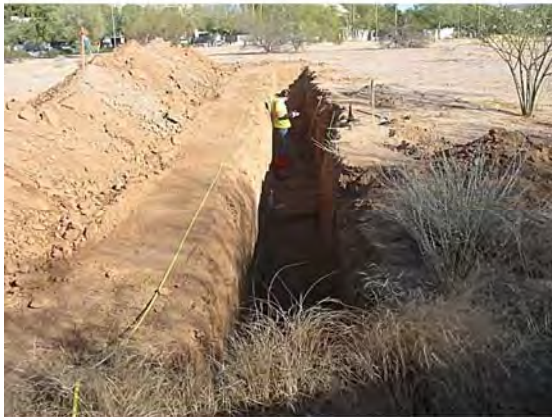
Photo 1: View of trench from southwest toward northeast.

Two earth fissures cracks were located in this trench. Fissure F3 is located approximately 29 ft. from the north end of the trench. See Photos 2, 3, and 4 for details.

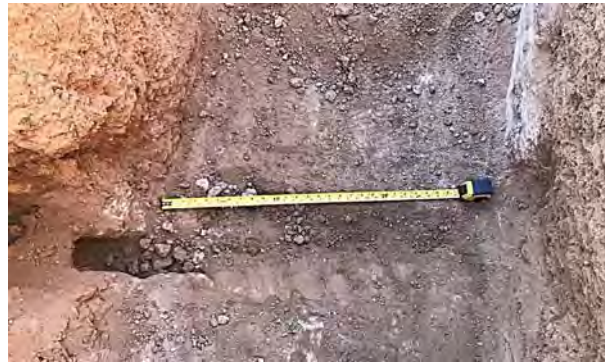
Photo 2: Earth Fissure F3 crack exposed across the bottom of the trench. The crack was found in caliche cemented soil about 0.4 feet wide and is filled with a brown silty sand with small fill debris. Fill bridges open fissure crack about 6.5 ft. bgs. Fissure bearing is N86°W.

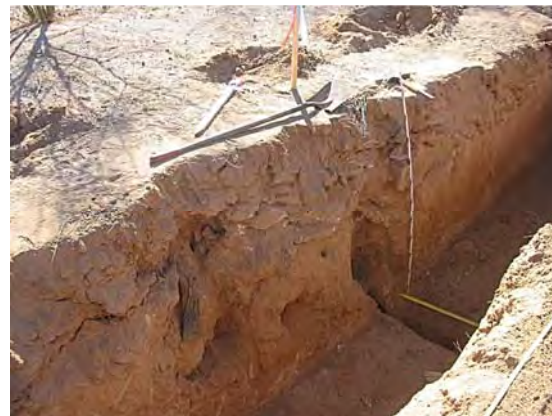
Photo 3: Earth Fissure F3 exposed in east wall and bottom of trench wall. Width of fissure gully rubble backfill zone about 10 ft. wide along parallel to trench wall. Several lateral to sublateral, partially fill erosion pipes exposed in trench wall. Fissure azimuth is N65°W.

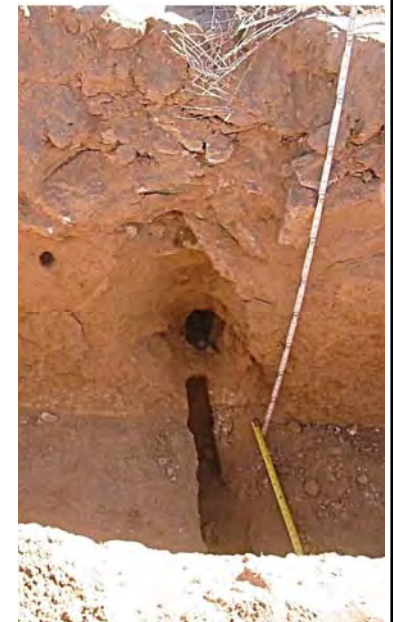
Photo 4: Soil profile adjacent to fissure crack in east trench wall:

0 - 1.1 ft. bgs - Old fissure gully fill. Concrete rubble in silty sand with gravel fill mixed with caliche fragment.

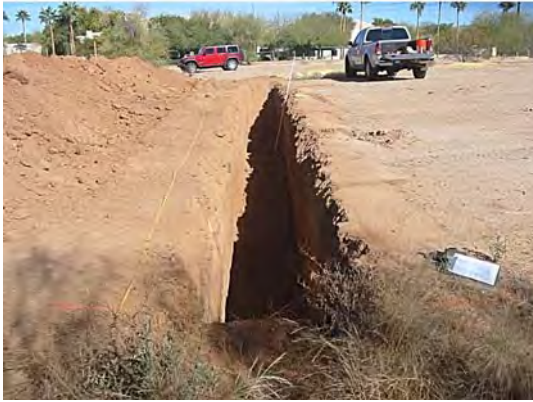
Photo 1: View of trench T2 from the south-southwest looking Toward the north-northeast.

The primary earth fissure F4 was exposed in this trench. A secondary tension crack, associated with F4 was also exposed about 2 ft. Fissure F4 is located approximately 24 ft. from the north end of the trench, See Photos 2, 3, and 4 for details.

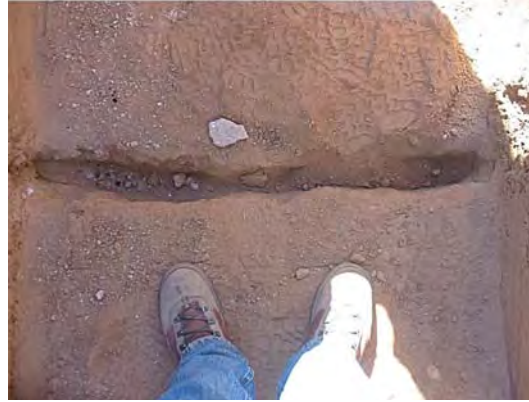
Photo 2: The primary earth fissure F4 is exposed across the bottom of the trench. The Earth fissure crack, about 0.15 ft. to 0.25 ft. wide, was found in caliche cemented soil below the fill and is filled with brown, fine silty sand with gravel. The fissure gully and fissure fill bridges open fissure crack about 5.5 ft. bgs. The earth fissure bearing is N68°W.

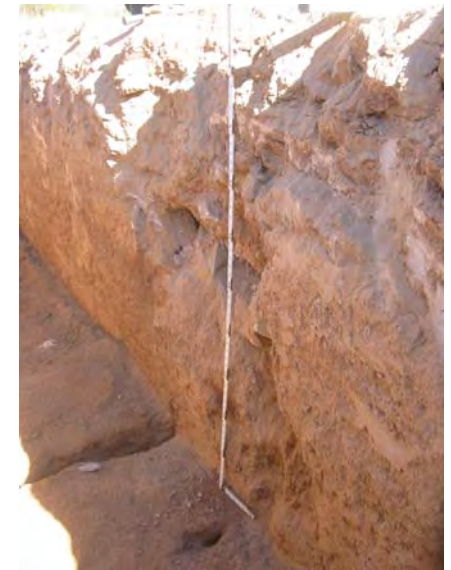
Photo 4: Soil profile adjacent to the F4 fissure cracks in east wall of Trench 2:

0 - 3.3 ft. bgs - Old fissure gully fill. Large concrete rubble fragments (about 0.4 ft to 0.7 ft. in diameter) included with a matrix of loose silty sand. Fill contains numerous voids.

5.0+ ft. to bottom - caliche cemented silty sand w/ gravel.

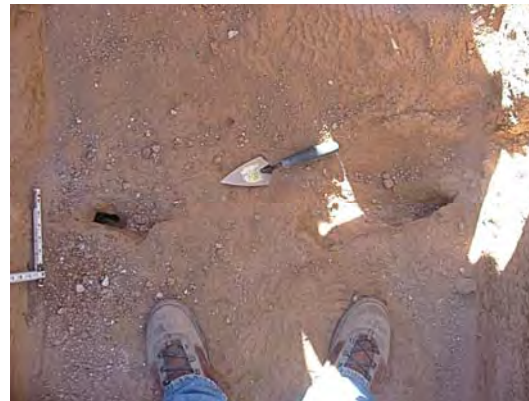
Photo 3: Subsidiary earth fissure-related tension crack (south) about 2 feet south of F4. This crack, with an aperture of about 0.09 ft. to 0.15 ft., was exposed across the bottom of the trench with . This crack opened up into a void a couple of inches below the bottom of the trench. Fissure bearing is N67°W.

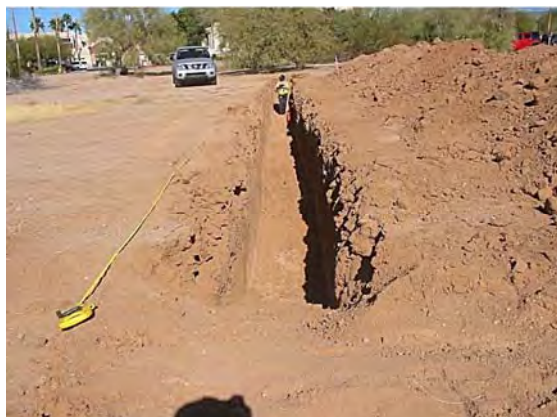
Photo 1: View of trench T3 from the southwest looking toward the northeast.

The earth fissures F5 was exposed in this trench. F5 is located approximately 22.5 ft from the north end of the trench. See Photos 2, 3, and 4 for details.

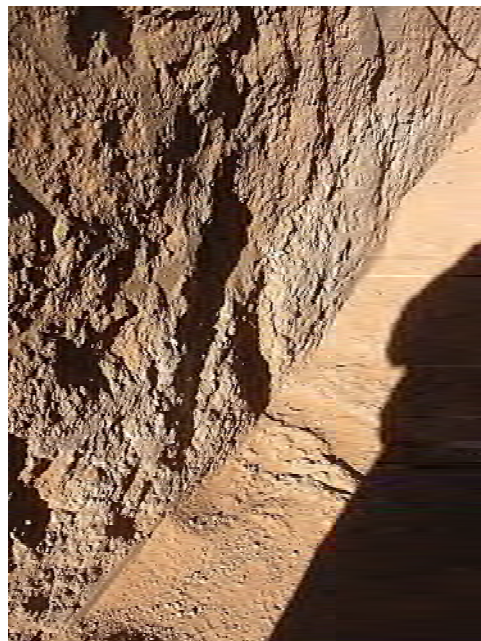
Photo 2: View of west trench wall exposing earth fissure F5 across the bottom of the trench and in the trench wall. The aperture of the earth fissure crack in the west wall is about 0.80 ft. to wide. In the trench, the fissure is filled with fine silty sand with some coarse sand with some trash. The earth fissure gully fill, and the fissure crack fill, bridge an open fissure crack below the bottom of the trench.

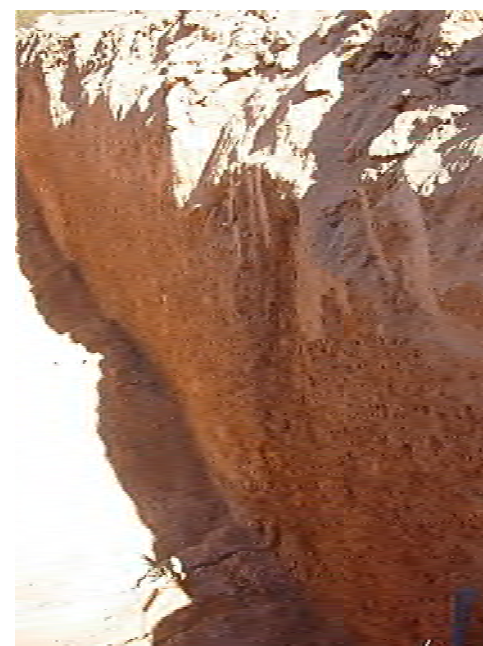
Photo 3: Earth fissure F5 exposed in the bottom of the trench. This photo clearly shows this wide fissure aperture filled with silty, fine to coarse sand crack, that bridges the earth fissure. See Photo 4 that depicts the wide (about 1.4 ft.) filled fissure crack (darker, near vertical soil column) extending upward to the base of the fissure gully fill zone in the east wall of the Trench 3.

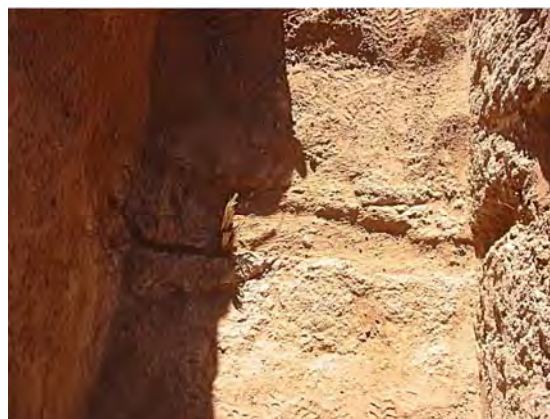
Photo 4: Soil profile adjacent to the F5 fissure cracks in east wall of Trench 3:

0 - 0.9 ft. bgs - Old fissure gully fill zone. Dense to loose silty sand mixed with some trash. .

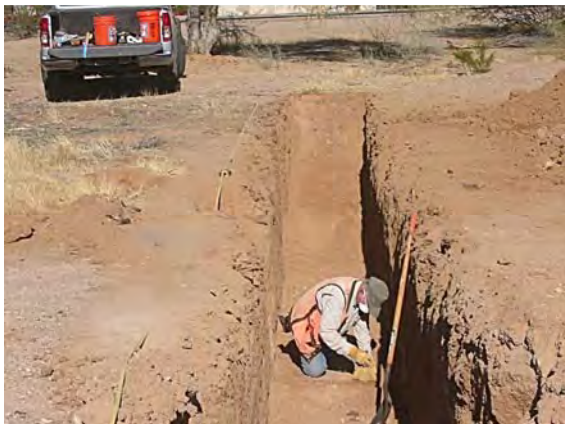
Photo 1: View of trench T4 from the south-west looking toward the northeast.

The earth fissures F6 and F1-1 were exposed in this trench. F4 is located approximately 30 ft from the north end of the trench and F1-1 is approximately 50 feet from the north end of the trench, See Photos 2, 3, and 4 for details.

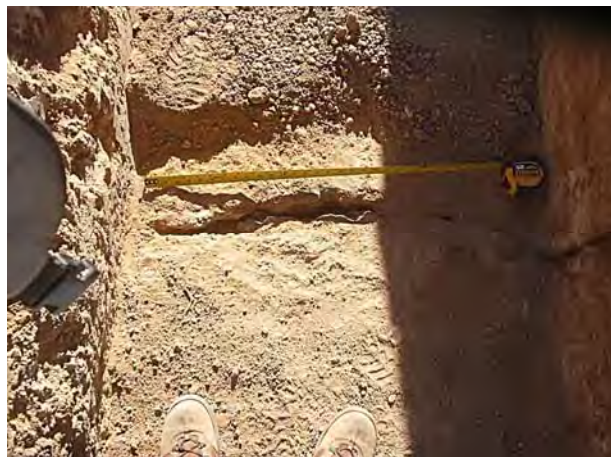
Photo 2: Earth fissure F6 is exposed across the bottom of the trench. The earth fissure crack, about 0.45ft. to 0.9 ft. wide, was found in caliche cemented soil below the overburden soil. The gully fill is with light brown, silty coarse sand mixed with trash and asphaltic concrete rubble. The fissure fill bridges open fissure crack to more than 5 ft. bgs.

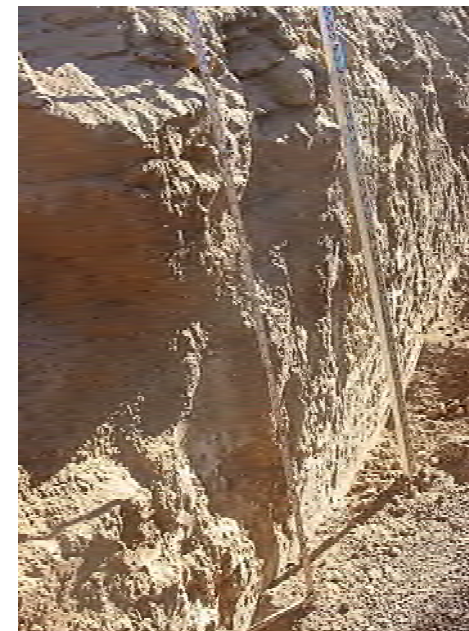
Photo 4: Soil profile adjacent to the F6 fissure cracks in east wall of Trench 4:

0 - 1.2 ft. bgs - Old fissure gully fill. Asphaltic concrete rubble and trash in a matrix of coarse sand. Width of fissure gully fill at trench top is about 8 ft.

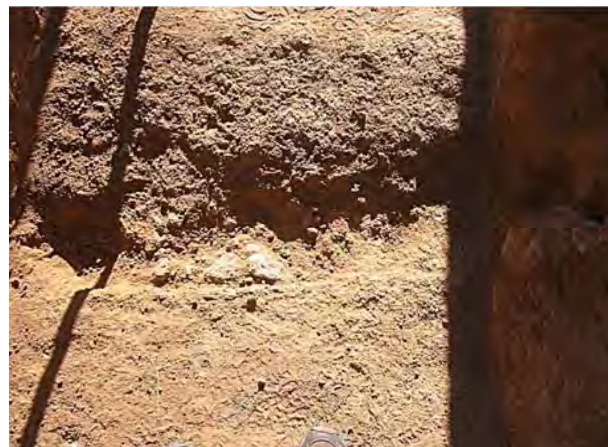
Photo 3: The second earth fissure crack cut the trench bottom about 20 ft. south earth fissure F6. This crack, with an aperture of about 0.02 ft. to about 0.06 ft., appeared to be partially open on the west side of the trench. Most of the fissure bridged with a thin cover silty coarse sand. The bearing of fissure F1-1 in the trench is N62°W.

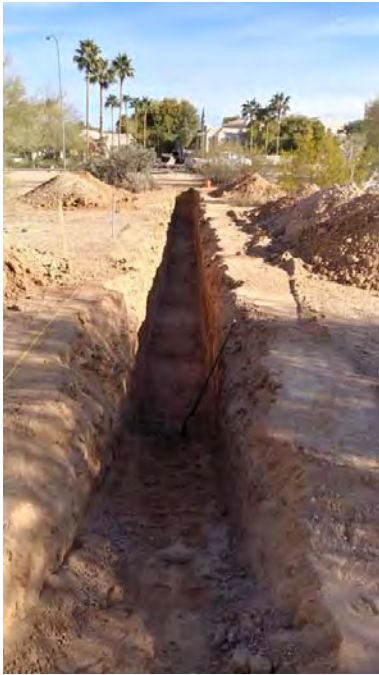
Photo 1: View of trench from southwest toward northeast.

Two earth fissures cracks were located in this trench. One (F7) approximately 48' from the north end of the trench; and, one (F1-2a approximately 70.5' from the north end of the trench. See Photos 2, 3, and 4 for details.

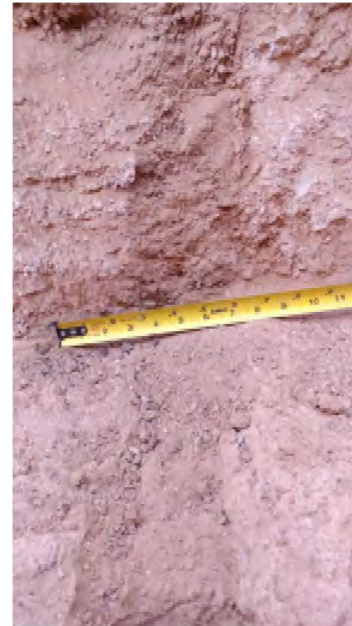
Photo 2: Earth Fissure F7 crack exposed across the bottom of the trench. The crack was found in caliche cemented soil, is between 3" and 6" wide and is filled with a silty sand, slightly redder than the surrounding soil. Fissure azimuth is N63°W.

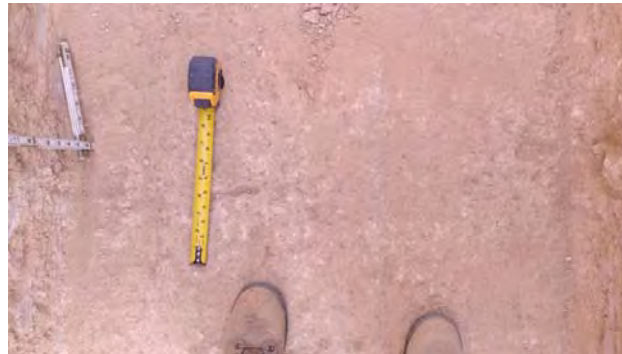
Photo 3: Earth Fissure F1-2a exposed in caliche cemented soils across trench bottom. Crack is approximately 1/2" to 1" wide and filled with silty sand. Fissure azimuth is N65°W.

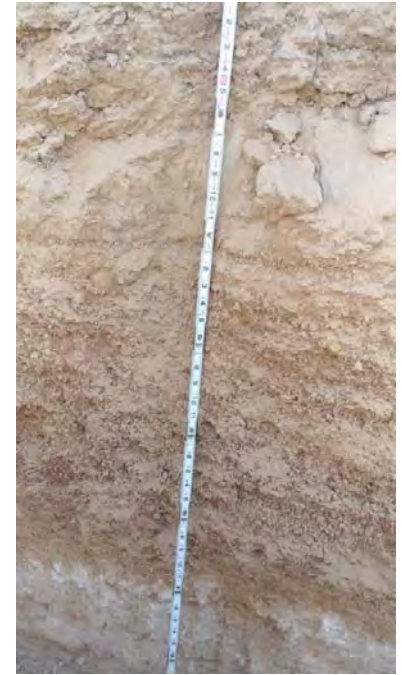
Photo 4: Typical soil profile in trench wall:

0 - 10" bgs - silty sand fill soil, tan, loose, unconsolidated.

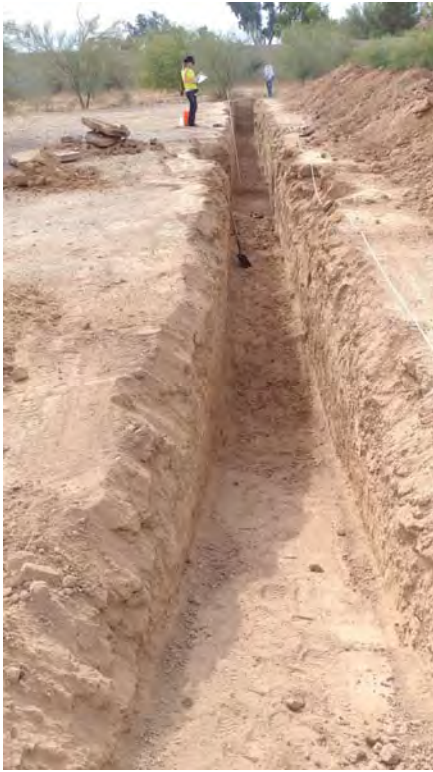
Photo 1: View of trench from north-east to southwest.

One earth fissure crack (F8) was located in the bottom of the trench, approximately 45' from the north end of the trench. See Photos 3 and 4 for details.

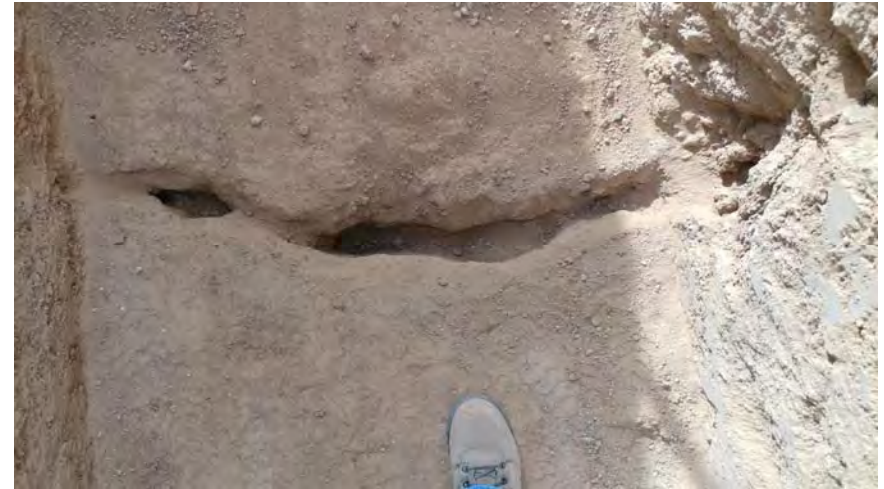
Photo 2: Earth Fissure F8 crack exposed across the bottom of the trench. The crack was found in caliche cemented soil, is approximately 3.5" wide with open voids below. The crack forms the southern boundary of an "earth fissure zone" which is approximately 6' to 6.5' wide and is characterized by a large slump north of the crack (Photo 3). The fissure crack trends N85°W.

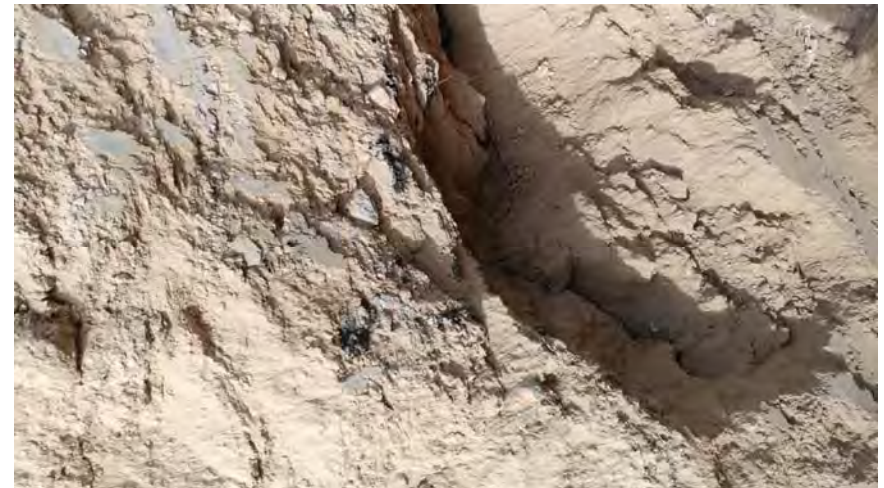
Photo 3: The "slump" appears at the northern boundary of the earth fissure zone. It was filled with concrete and asphalt debris. The trench depth extended below the debris, into natural soil, where the cracking and slumping were apparent.

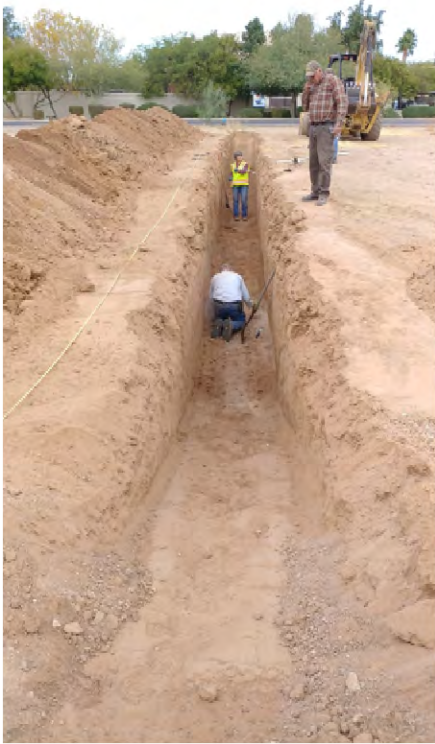
Photo 1: View of trench from north-east to southwest.

One earth fissure crack (F9) was located in the bottom of the trench, approximately 45' from the north end of the trench. See Photos 3 and 4 for details.

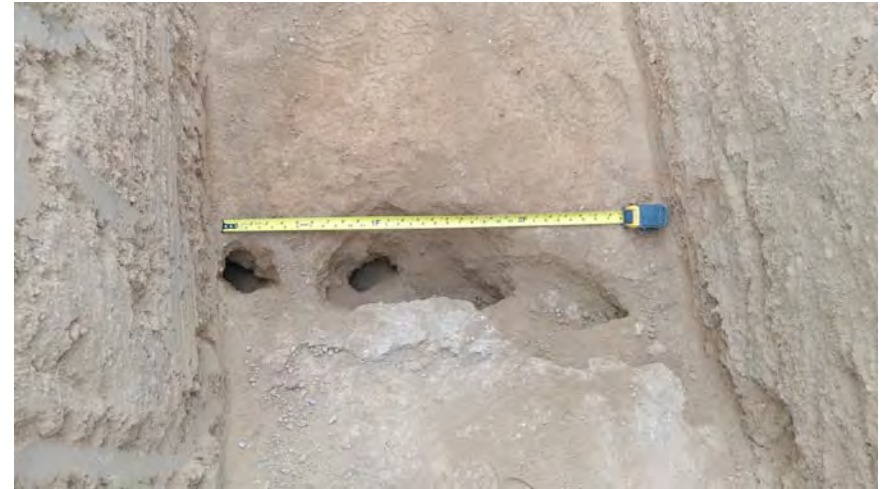
Photo 2: Earth Fissure F9 crack exposed across the bottom of the trench. The crack was found in caliche cemented soil, is approximately 1" to 1.5" wide with erosion creating an approximately 3" wide void. The fissure crack trends N43°W.

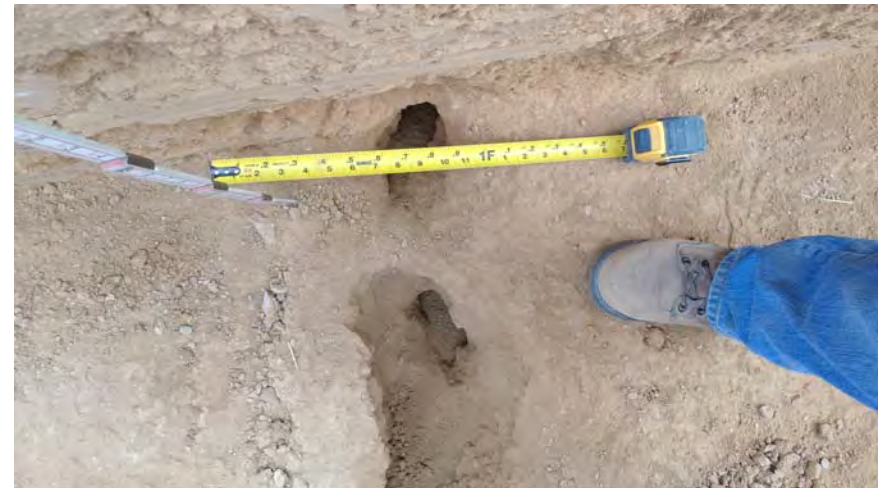
Photo 3: Another view of the eroded fissure crack as it extends into the northwest trench wall.

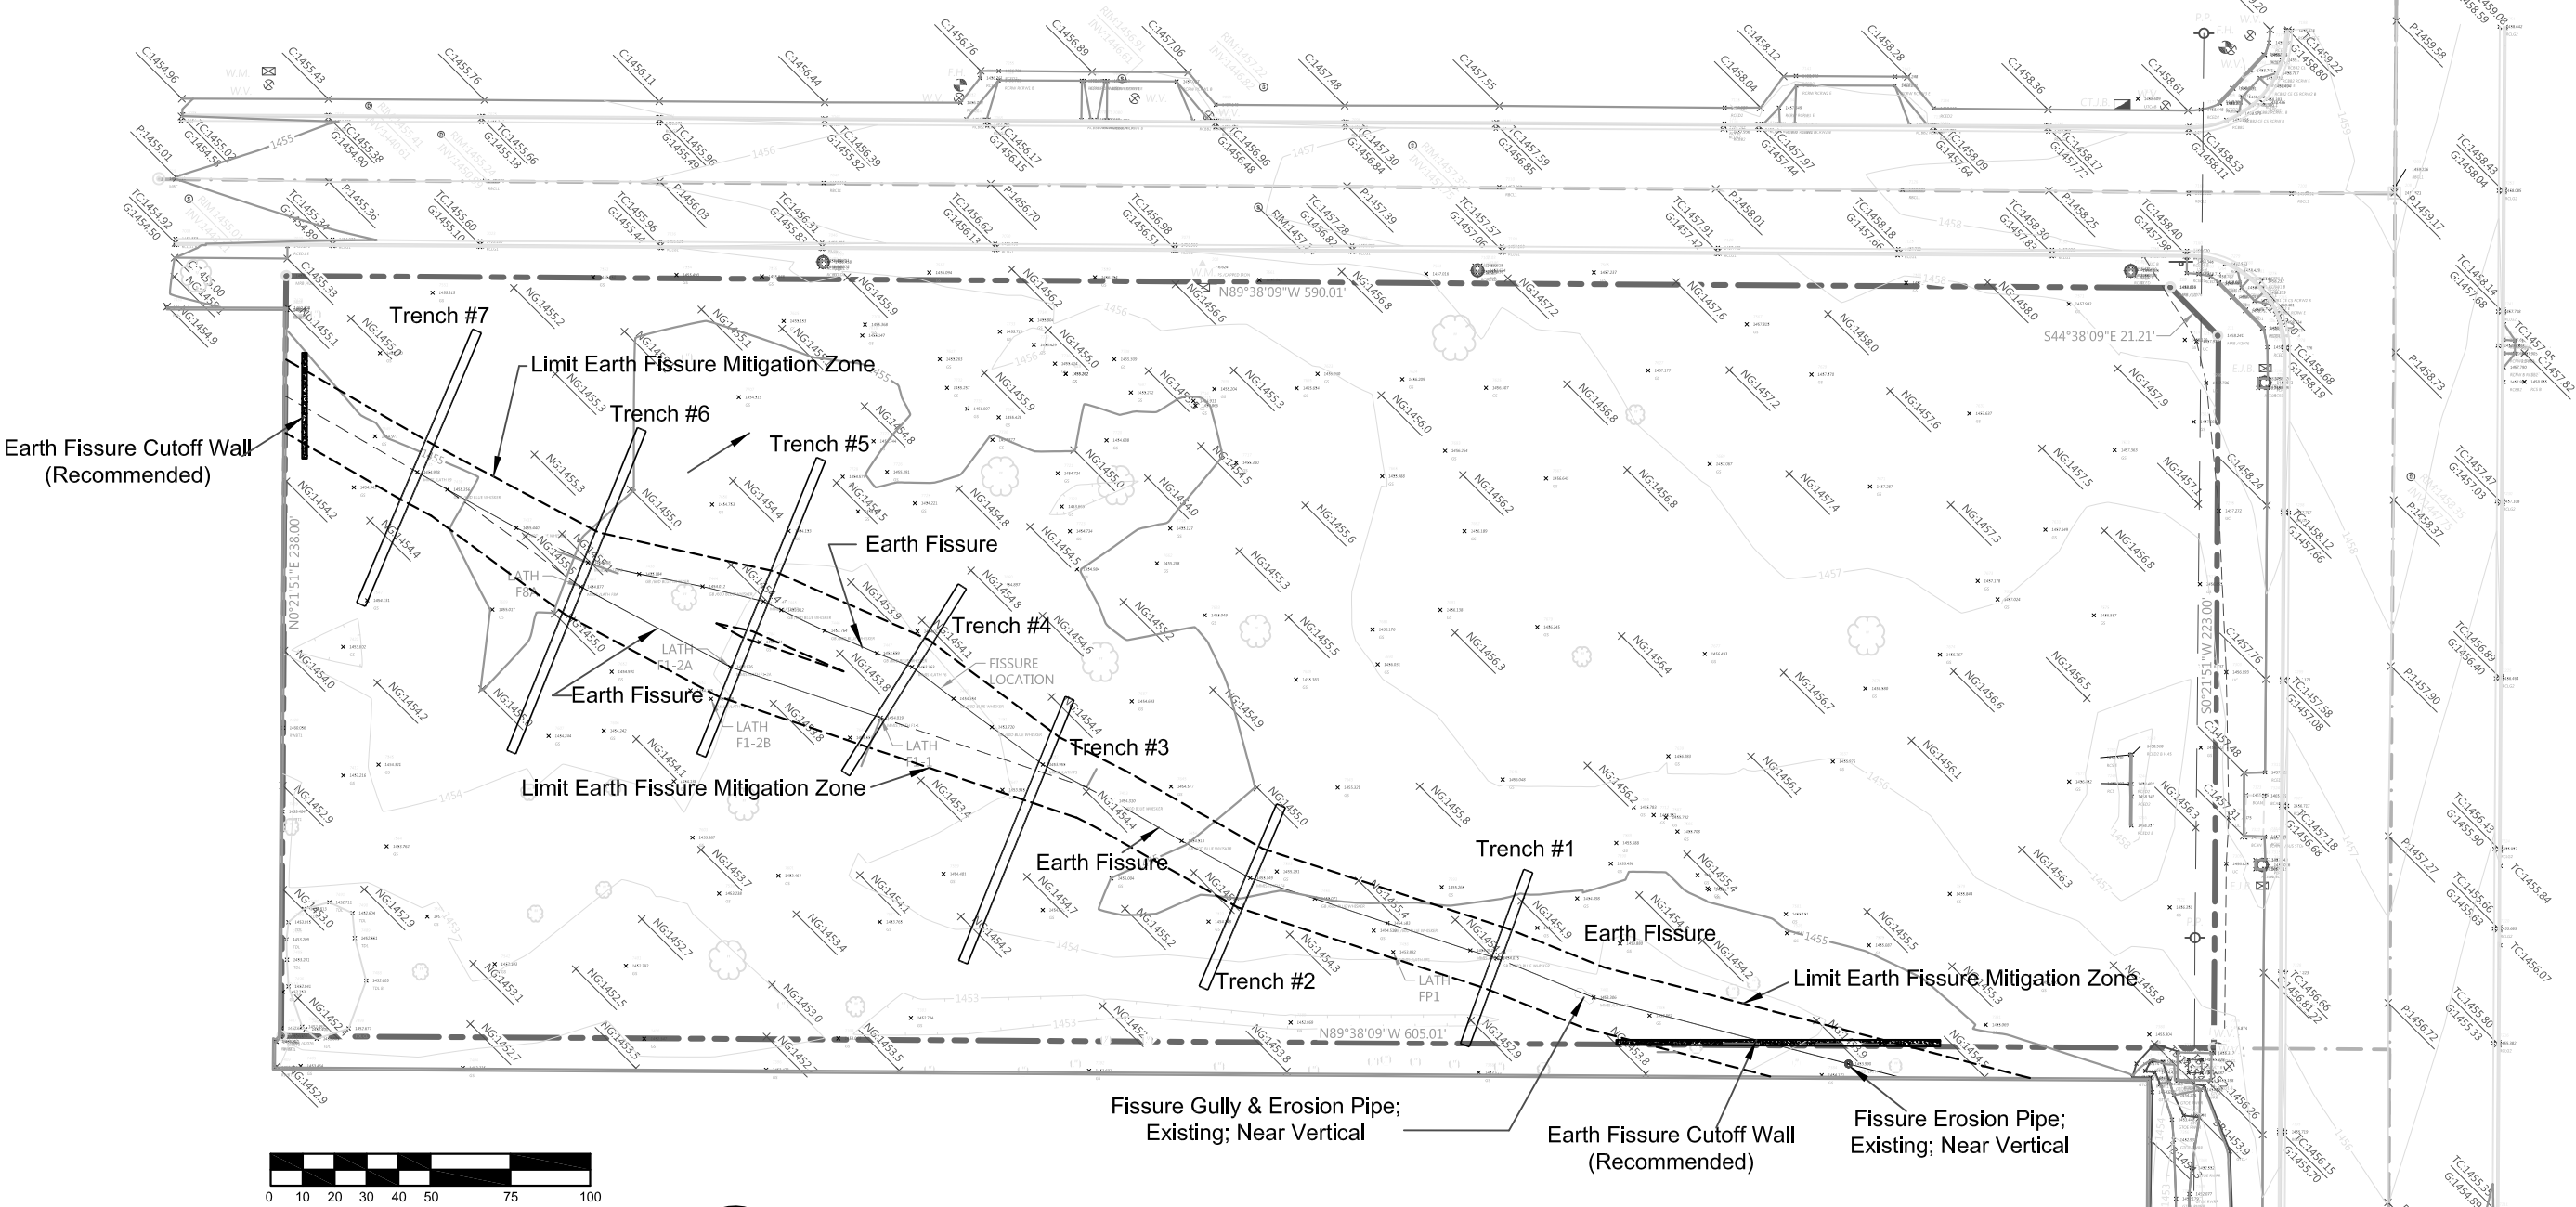
1 EARTH FISSURE MITIGATION ZONE LOCATION MAP

- 2.2** AzGS reported one mapped earth fissure on the project site, trending from the southeast to northwest property corners. The Task 2 subsurface exploration program confirmed this mapped earth fissure, and also a second earth fissure which appears to stem off from, and run parallel to the original fissure, then curve back toward the primary earth fissure (Sheet 1).

- 2.8** Earth fissure mitigation plans and details are depicted in Sheets 1, 2, 3, and 4. The mitigation alternatives should apply to an area that covers a minimum of 10-feet along each side of the earth fissure trace as depicted in Sheet 2, Detail 1. The earth fissure mitigation zone can be expanded as necessary to allow for easy equipment access to backfill and compact the fill soils or for special conditions such as earth fissure or earth fissure gullies located within roadway and utility easements. We recommend the soil back fill should be compacted to at least 95-percent of the maximum density and optimum moisture content determined from standard Proctor soil tests (ASTM 698)
