## **APPLICATION FOR CITY OF MESA VARIANCE**

Paul Zonneveld for property address 3530 North Hawes Rd #6, Mesa AZ 85207 for City of Mesa Variance to encroach into required side yard setback

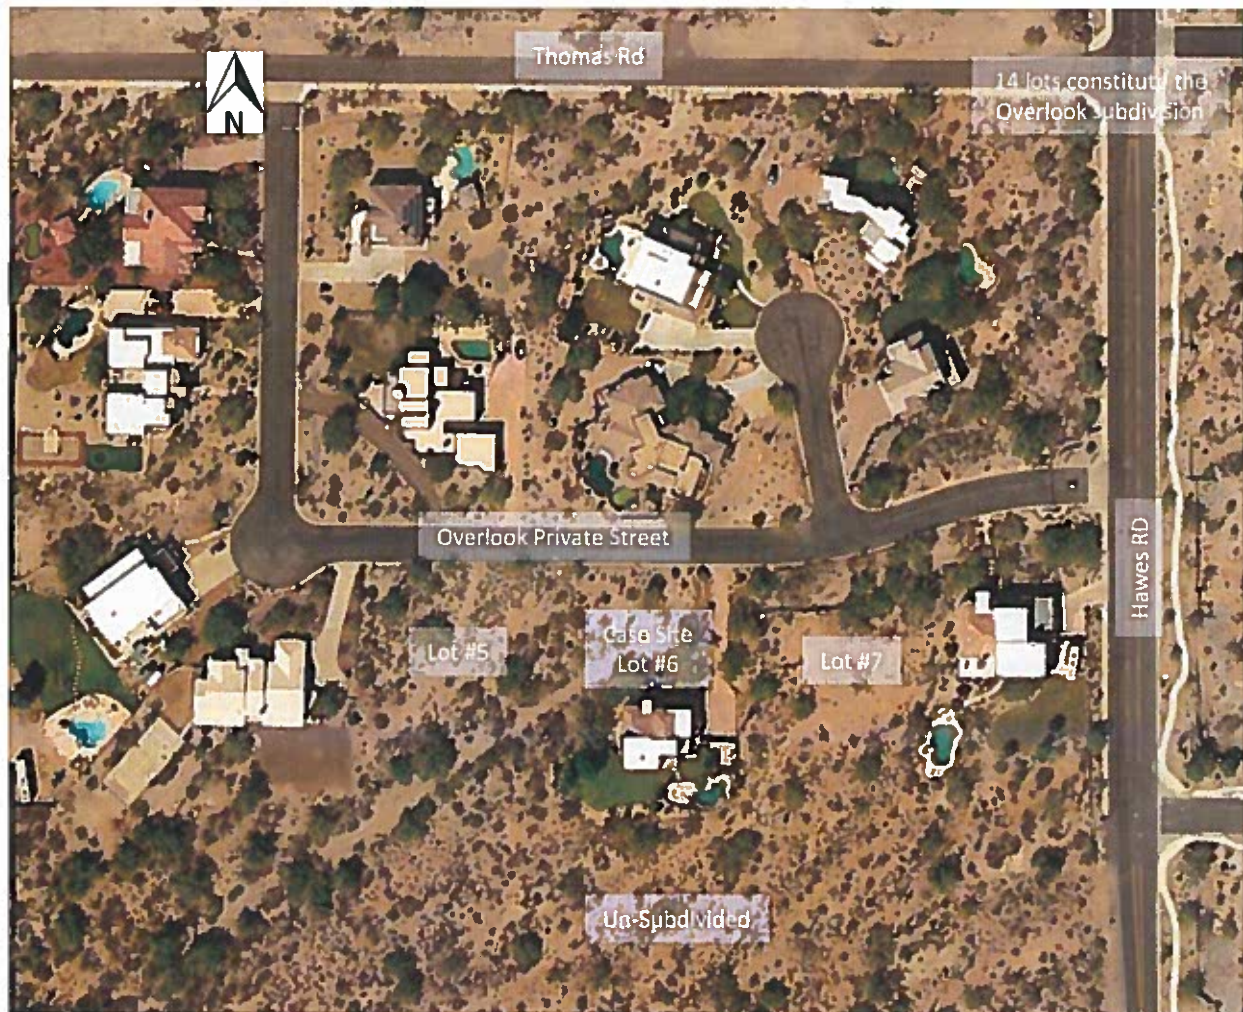
Figure 2-1: Case Site Context

Note: the lots to the East and West of the Case site are currently vacant open zoned RS-35 lots (reference Figure 2-1)

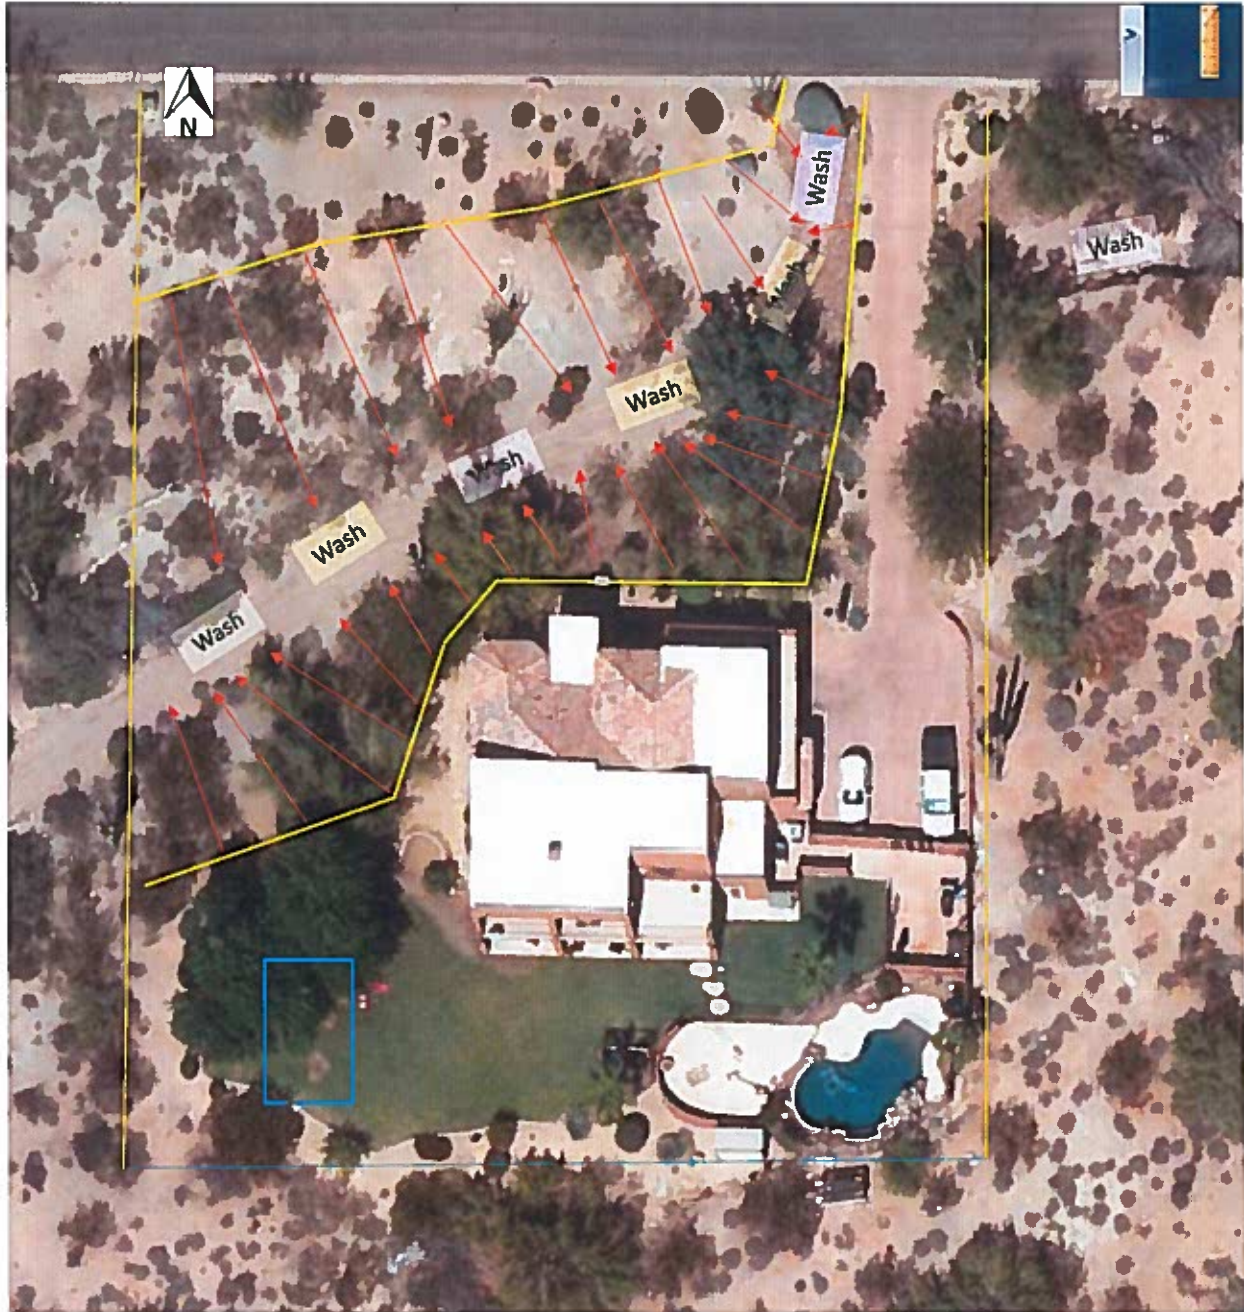
Lot #6 of the overlook subdivision is unique to all the surrounding properties in the location and passage of a natural wash that runs through the front of the property (reference Figure 4-1). As the figure shows the wash and the slopes of the wash take up approximately 35% of the surface area of the property. The wash bottom sits anywhere from 10 to 16 feet below the front of the property closest to the street and about the same heights relative to the area where the residence is located. The wash is fed by the drainage easement from property #12 and from adjacent property #7. The drainage easements and location of the wash preclude the construction of the proposed detached garage (reference section 4.5 Location #1 discussion) within the identified wash zone (the area within the yellow lines in Figure 4-1).

**Figure 4-1: Overall view of Lot #6 and Topography**

Lot #6 is also on a septic system and as identified in Figure 4-1 the septic system is located in the area identified in the blue box. The location of the septic system would preclude any construction in and around this area (reference section 4.5 Location #2 discussion).

Figure 4-1 also details the location of the pool located on Lot #6. Although having the pool on Lot #6 is not unique to the surrounding properties it located in the only available location considering the other restrictions of Lot #6.

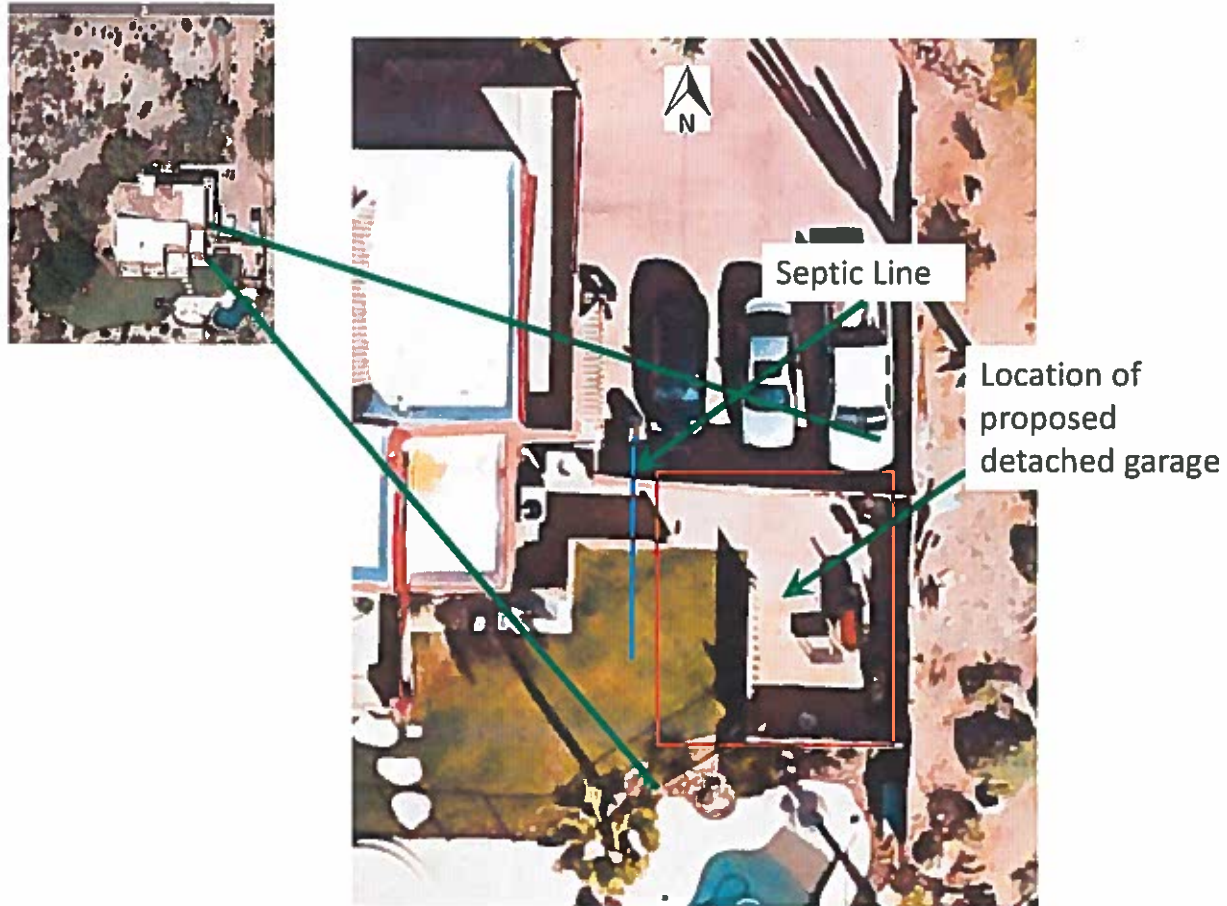
**Location #4:** This location is presented in Figure 4-2 in the area of the red box. The requested spacing, for the detached garage, is 26ft by 26ft (reference the attached site plan and floor plan). This location puts the eastern most wall of the proposed garage within 3.5ft of the eastern property line (reference the site plan). This location and the encroachment into the side yard setback is the justification behind the need for the setback variance.

**Figure 4-2: Proposed Detached Garage Location Relative to overall Property**

- As shown in Figure 4-2 there is a septic line (shown by the blue line) that would be covered up by the foundation of the proposed garage if constructed in this area and for this reason this location was eliminated.

The outline of the proposed detached garage is shown in Figure 4-2, is detailed further below. The attached Site Plan, Floor Plan, and Elevation views give additional context to the requested variance for construction of the proposed detached garage.

The remaining wall section shown attached to the corner of the existing single car garage (Reference Figure 4-2 just west of the blue septic line) will be maintained and a new access

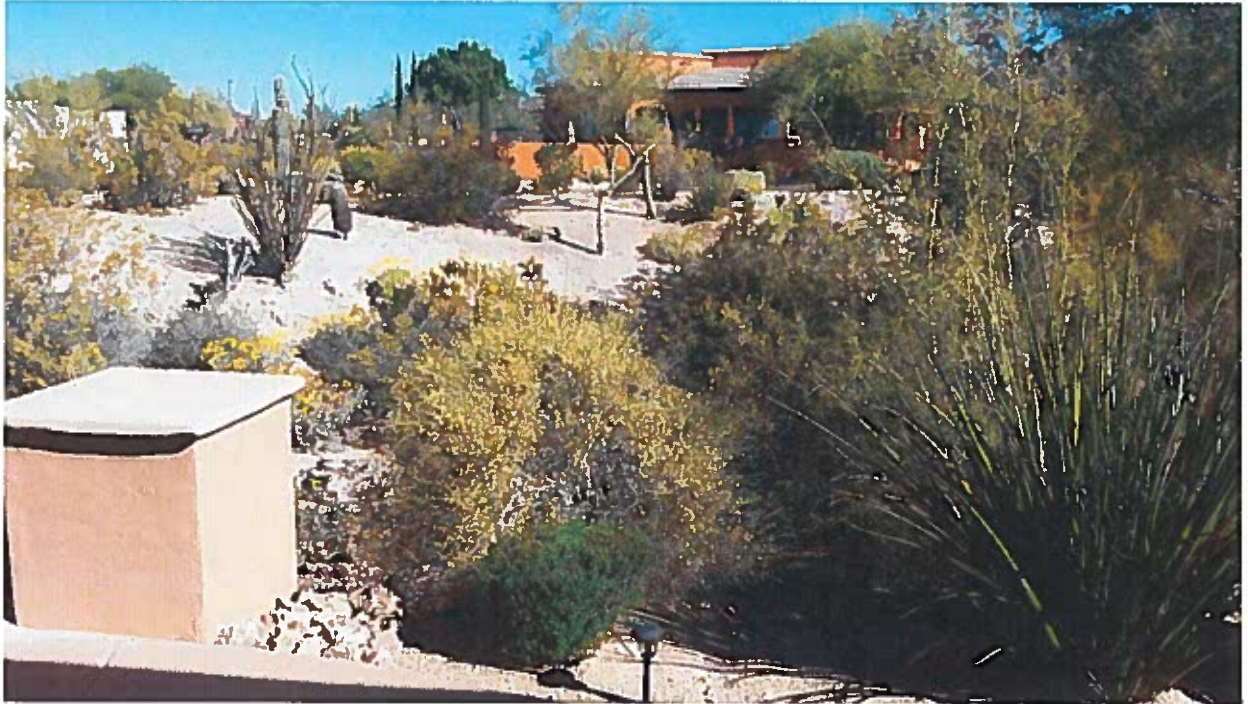
**Picture #1 [Below] (Reference Figure 5-1):** Picture #1 shows the northern direction view of Lot #6 from the position shown. This picture gives some context to the depth of the wash on Lot #6 and also shows the sloping wash bank up to the street level.

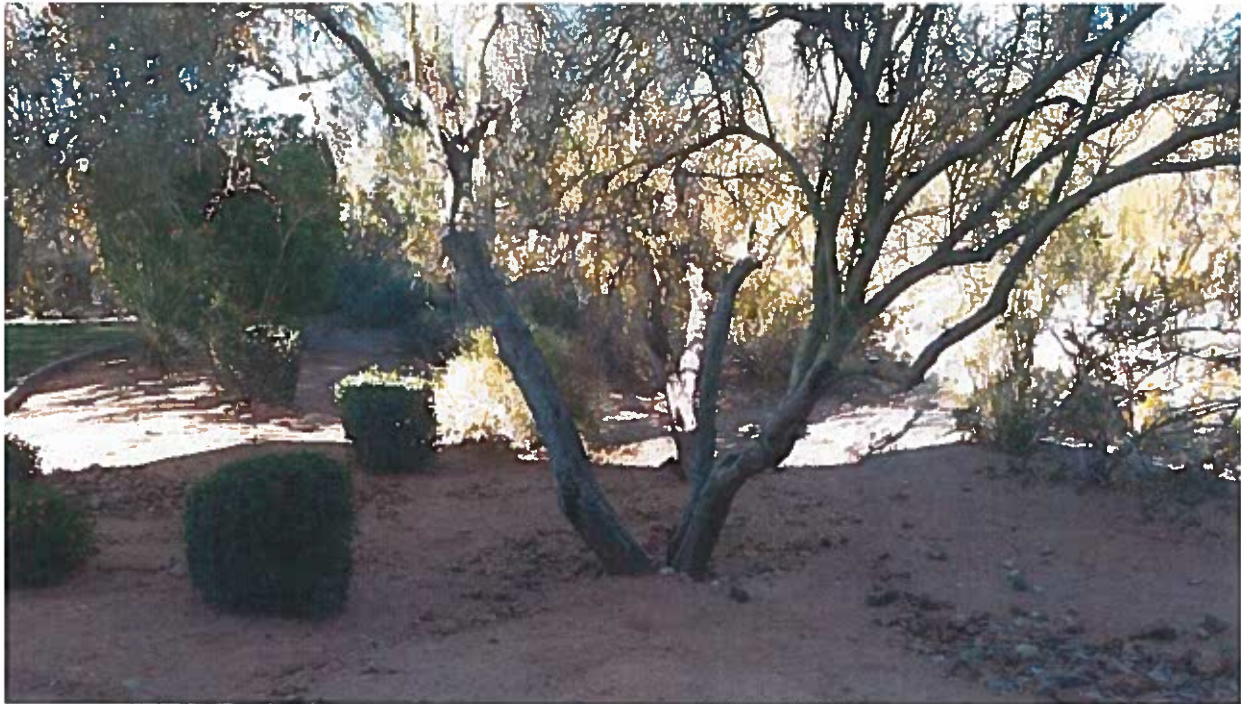
**Picture #2 [Below]** (Reference Figure 5-1): Picture #2 shows the western direction view of Lot #6 from the position shown. There are some trees in this location of Lot #6 and this picture shows the slope bank to the wash continues in the western view of the lot.

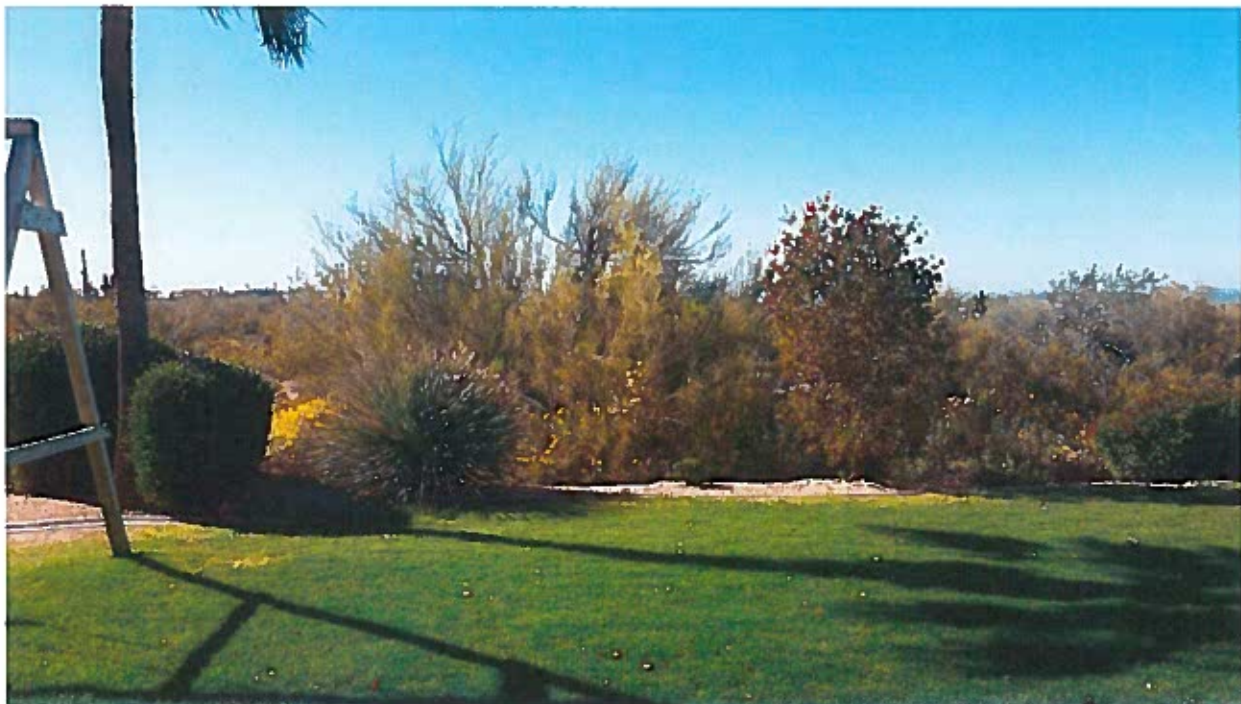
**Picture #3 [Below]** (Reference Figure 5-1): Picture #3 shows the southern direction view of Lot #6 from the position shown. This picture gives a view of the un-subdivided lot to the south of Lot#6.

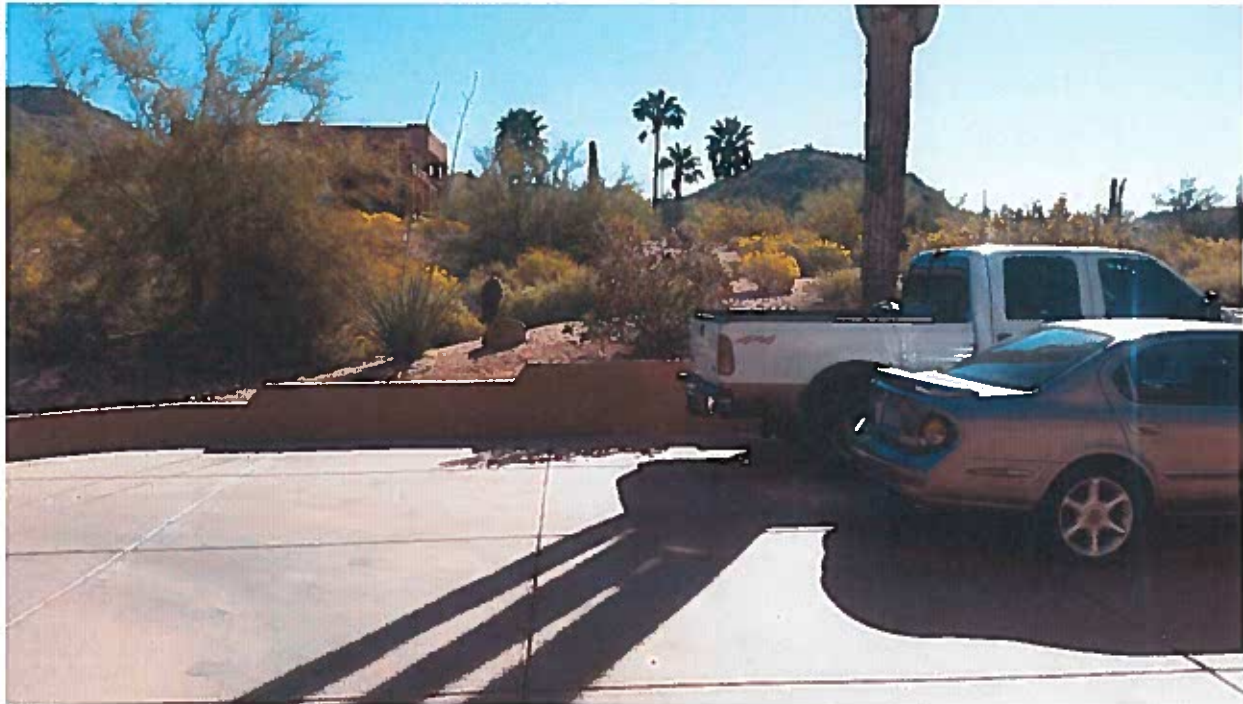
**Picture #4 [Below]** (Reference Figure 5-1): Picture #4 shows the eastern direction view of Lot #6 from the position shown. This picture gives an appreciation of Lot #7 and the height of the lot above Lot #6. The flat part of Lot #7 sits more than 9ft above Lot #6.

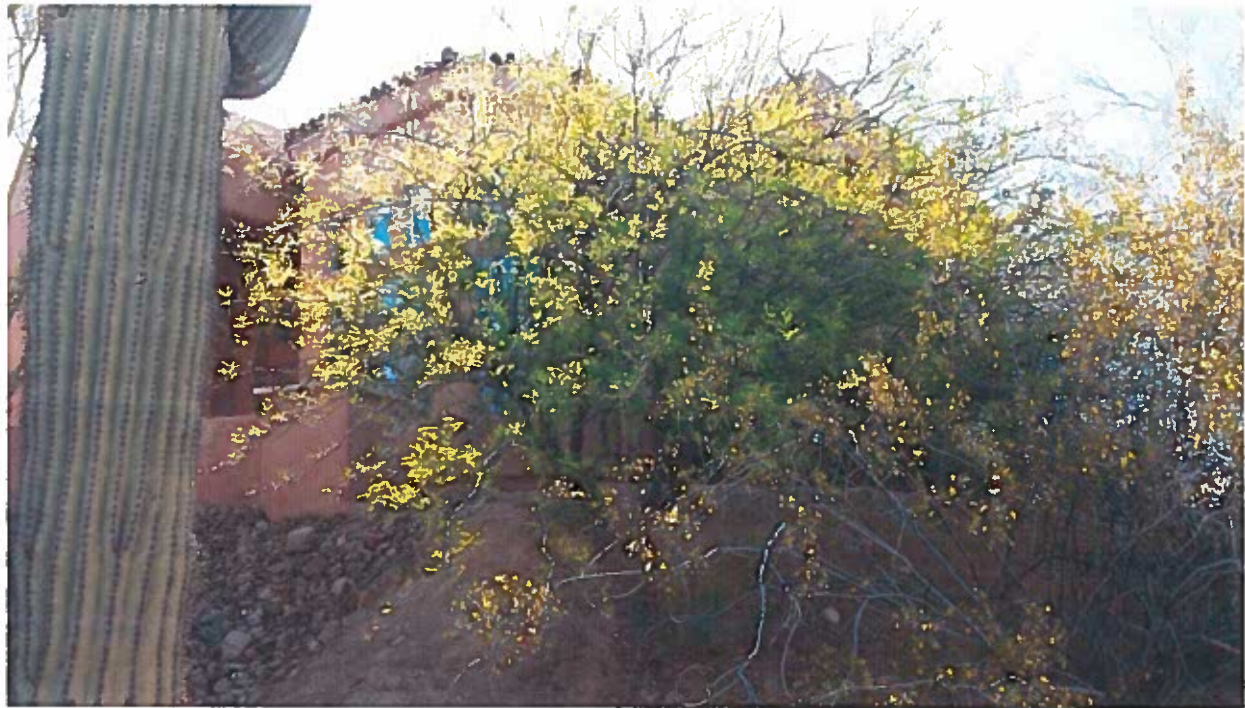
**Picture #5 [Below]** (Reference Figure 5-2): Picture #5 is taken from the wash bottom up towards the corner of the residence as shown. This figure shows the upward slope of the wash.

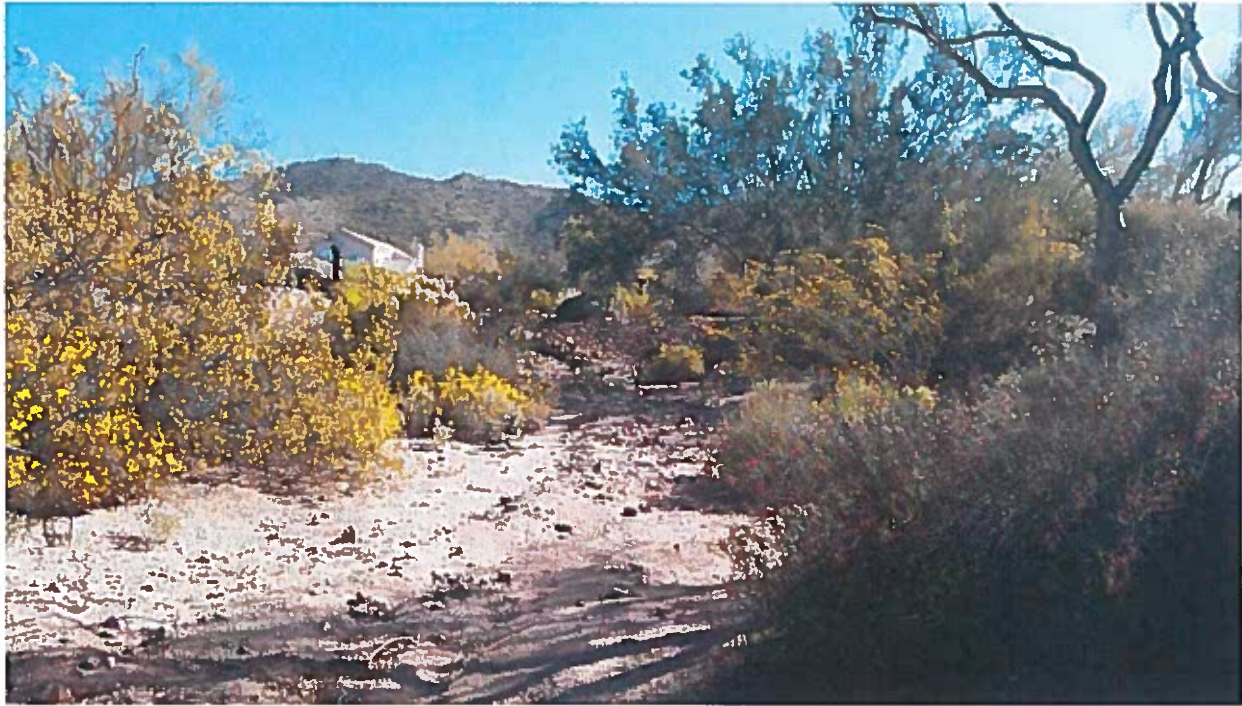
**Picture #6 [Below]** (Reference Figure 5-2): Picture #6 shows a view of the wash up to the driveway and illustrates the wide slopes on either side of the wash.

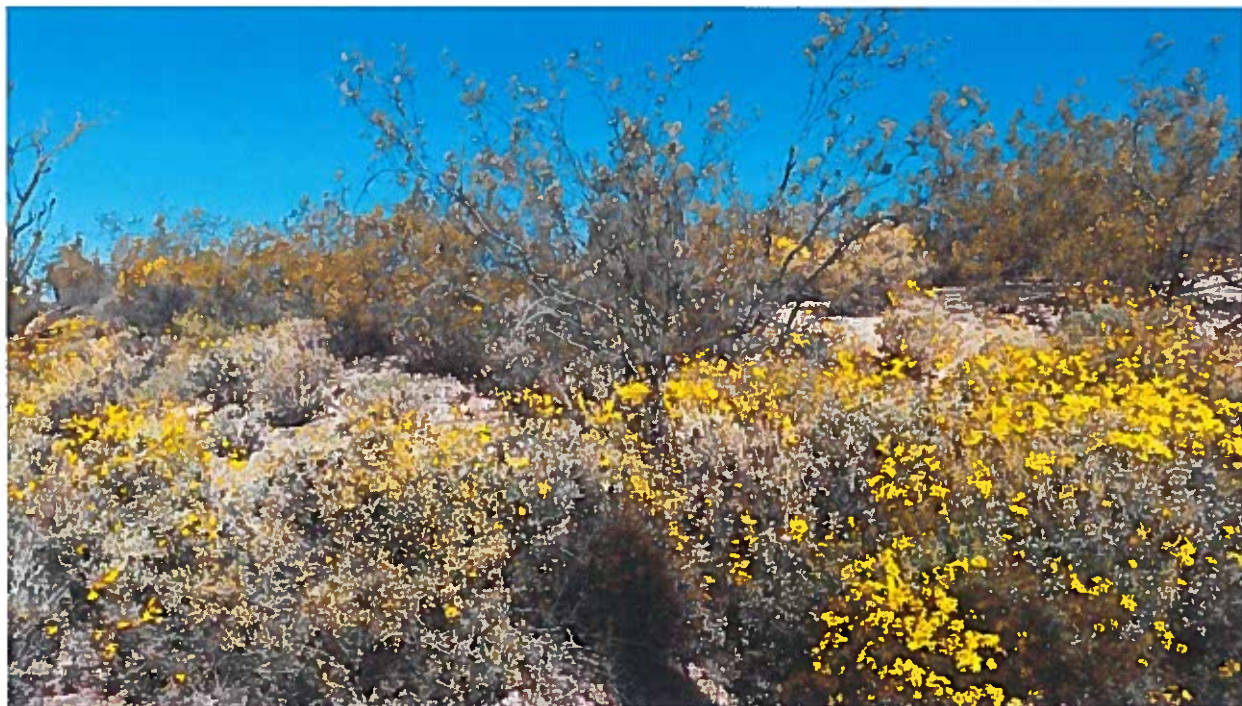
**Picture #7 [Below]** (Reference Figure 5-2): Picture #7 is important as it shows the large wash bank towards the north western corner of Lot #6 and reinforces the difficulty in locating any structure in this area.

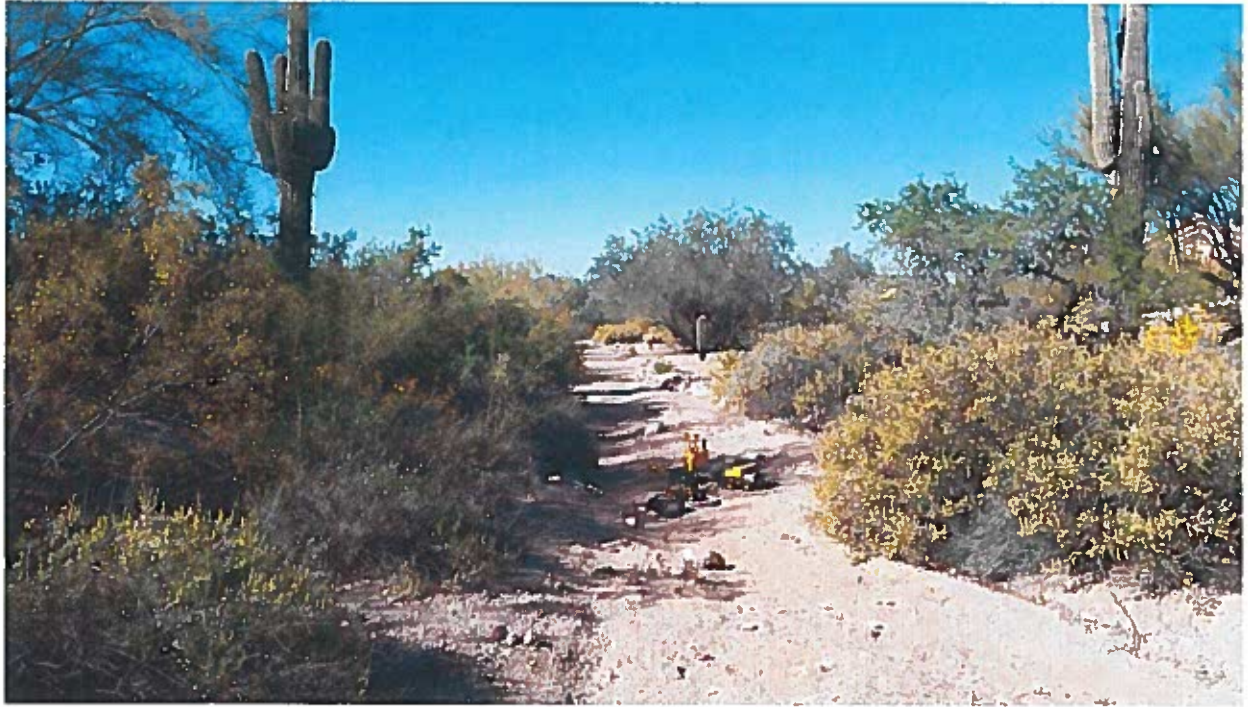
**Picture #8 [Below] (Reference Figure 5-2):** Picture #8 is a view down the wash as it progresses towards Lot #5.

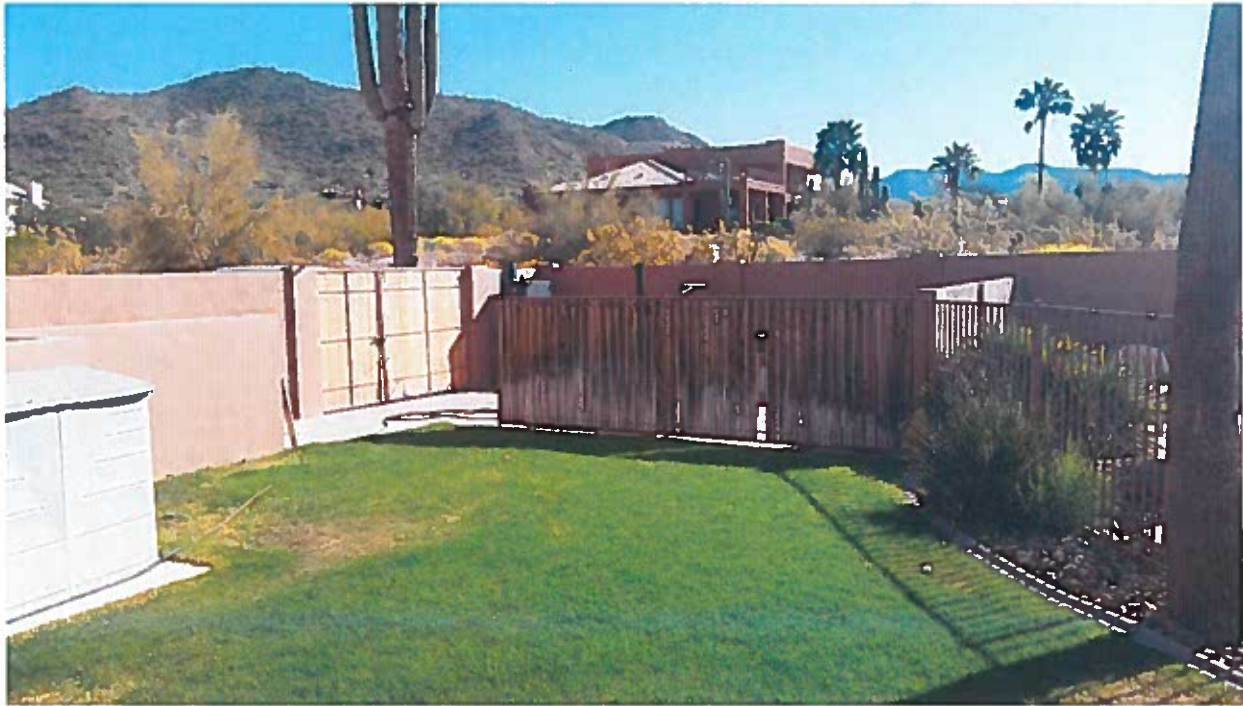
**Picture #10 [Below]** (Reference Figure 5-3): Picture #10 is a view of the location for the proposed detached garage.

The outline of the detached garage measures 26ft X 26ft and has an overall height of 16ft (including the parapet wall and flat roof which matches the construction of the existing residence and the other homes in the Overlook subdivision. The existing privacy block wall in place on Lot #6 will remain in place and the foundation wall of the eastern face of the garage will be constructed inside that wall and the gap between the two filled. The existing wall and wall foundation will not be disturbed. The existing concrete pad will be removed, with the exception of the afore mentioned eastern block wall, and a new monolithic slab poured in place to the 26ft X 26ft foot print. Figure 4-3 shows a preliminary view of the detached garage in a rendering of a framing structure. This preliminary rendering was used to guide the development of the Site Plan, Floor Plan, and Elevation views.

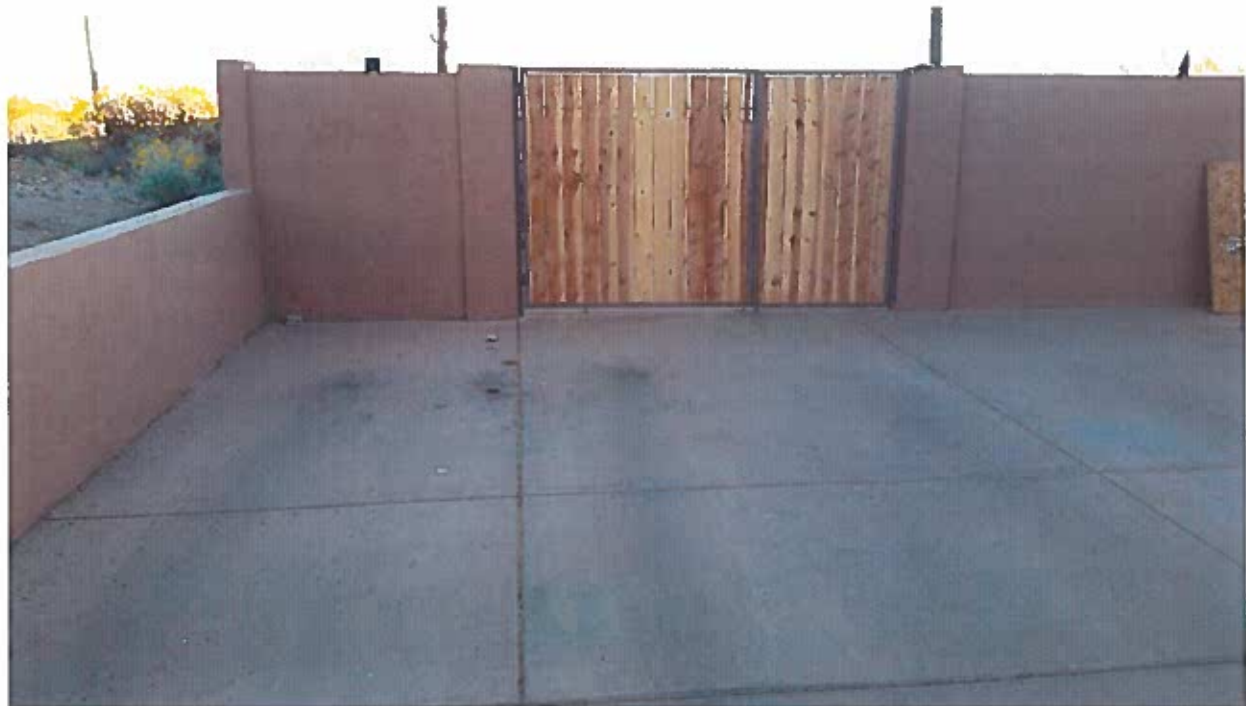
**Picture #11 [Below]** (Reference Figure 5-3): Picture #11 is a view looking towards the location where the proposed detached garage would be located and the existing gate and block wall currently in place.
