Minutes

Mesa City Council Chambers – Lower level, 57 E 1st Street
Date: February 3, 2026 Time: 5:00 pm

- 3-a. Discussion on the National Park Service Preservation Briefs that include but are not limited to Brief No. 14 (New Exterior Additions to Historic Buildings: Preservation Concerns), Brief No. 16 (The Use of Substitute Materials on Historic Building Exteriors), Brief No. 22 (The Preservation and Repair of Historic Stucco), Brief No. 25 (The Preservation of Historic Signs).**

MINUTES OF THE FEBRUARY 3, 2026 HISTORIC PRESERVATION MEETING

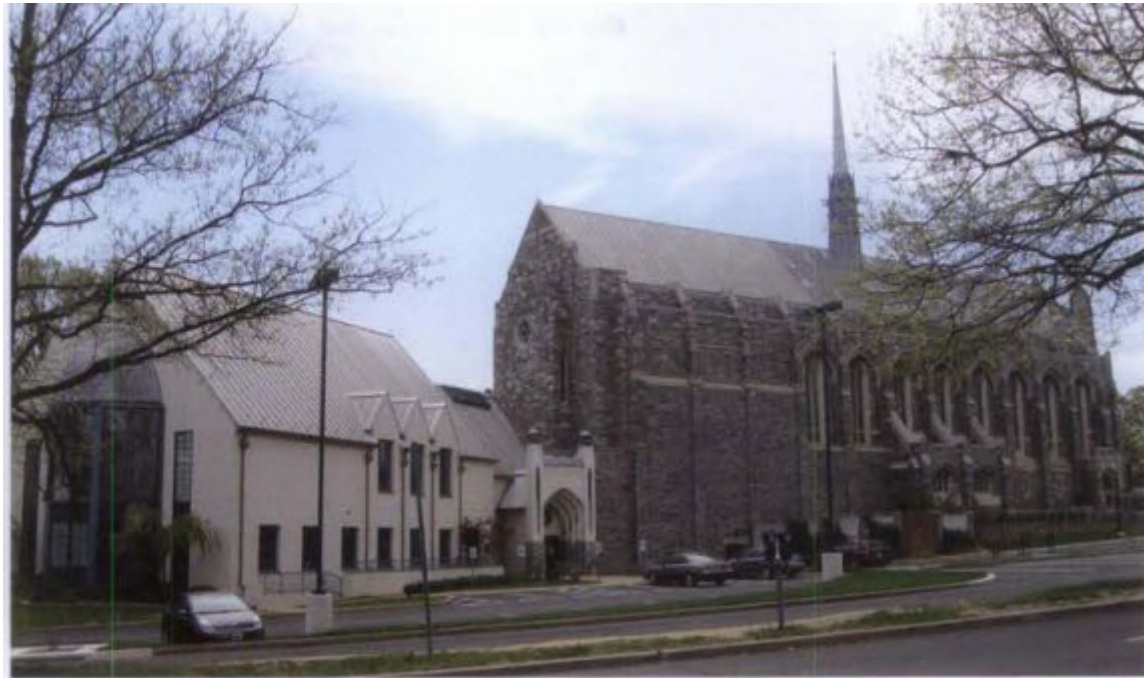
Figure 27. Although the new brick stair/elevator tower (left) is not visible from the front (right), it is on a prominent side elevation of this 1890 stone bank. The compatible addition is set back and does not compete with the historic building. Photos: Chadd Gossmann, Aurora Photography, LLC.

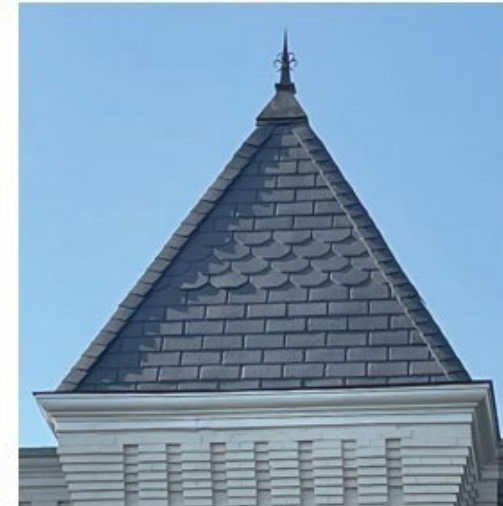
Figure 10. Polymer slates offer a choice of shapes but not sizes, limiting their ability to achieve a good visual match for some historic slate. With the size of the polymer slates (right) being nearly twice that of the historic slates (left), the scale of the entire feature is incompatibly altered. The molded edges of this material, which contribute to its ability to replicate slate, would be lost if each shingle was resized by cutting. Photo: John Sandor, NPS.

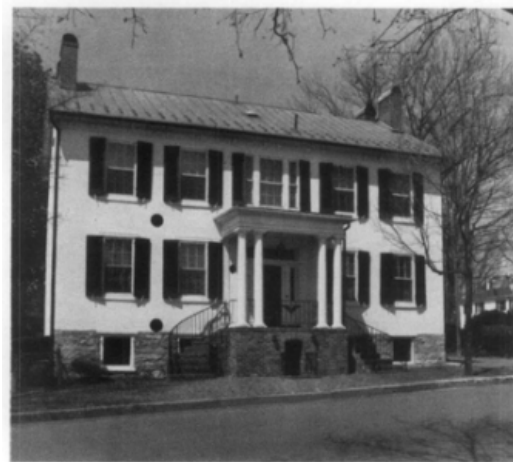
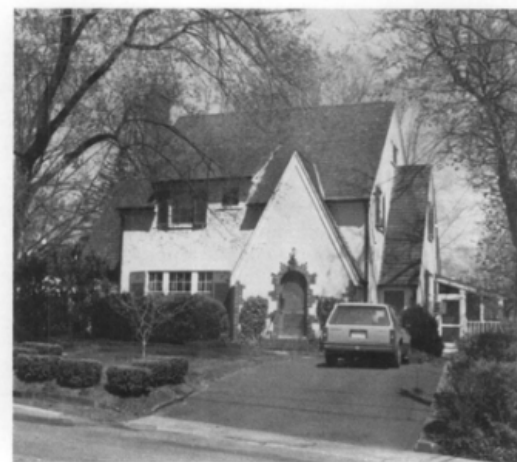
Fig. 1. These two houses in a residential section of Winchester, Virginia, illustrate the continuing popularity of stucco (a) from this early 19th century, Federal style house on the left, (b) to the English Cotswold style cottage that was built across the street in the 1930's. Photos: Anne Grimmer.

Stucco has been used since ancient times. Still widely used throughout the world, it is one of the most common of traditional building materials (Fig. 1). Up until

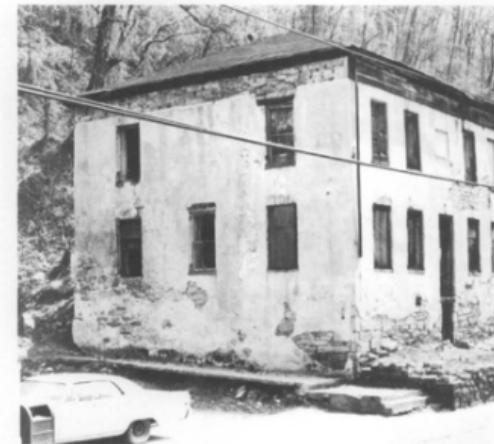
Fig. 7. Patches of stucco have fallen off this derelict 19th century structure exposing the rough-cut local stone substrate. The missing wood entablature on the side and the rough wood lintel now exposed above a second-floor window, offer clues that the building was stuccoed originally. Photo: National Park Service Files.

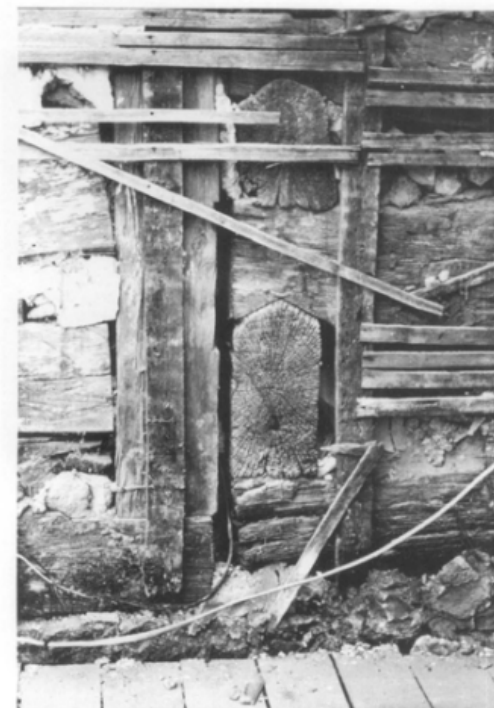
Fig. 8. Removal of deteriorated stucco in preparation for stucco repair on this late-18th century log house in Middleway, West Virginia, reveals that the stucco was applied to hand-riven wood lath nailed over vertical wood strips attached to the logs. Photo: Anne Grimmer.

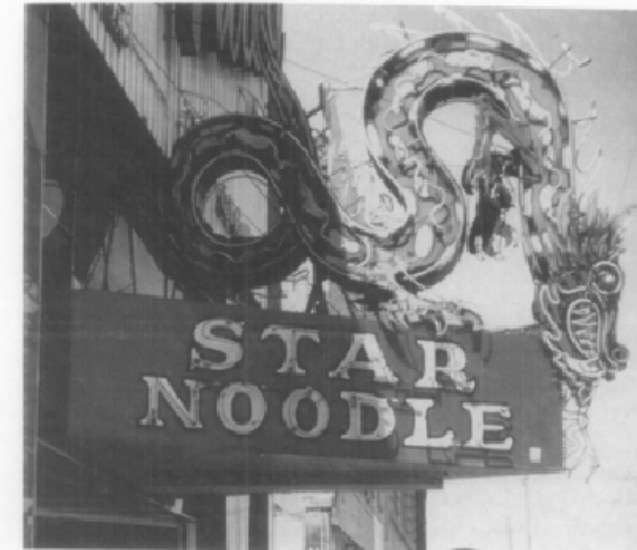
14. This Ogden, Utah, sign is a superb example of neon. Photo: deTeel Patterson Tiller.

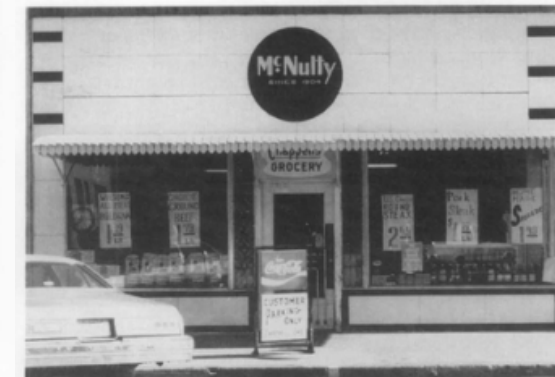
7. In the 1930s and 1940s, signs built into storefronts became popular. This example is from Guthrie, Oklahoma. Photo: H. Ward Jandl.
