Minutes

MINUTES OF THE FEBRUARY 3, 2026 HISTORIC PRESERVATION MEETING

Historic Preservation Board

Discussion on the
National Park
Service Preservation
Briefs

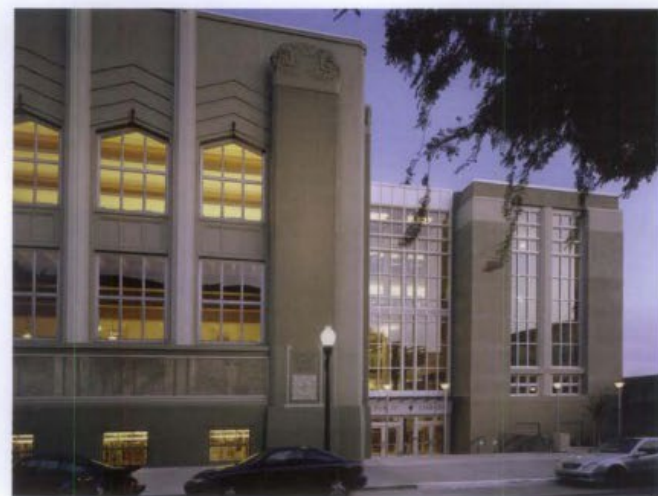
Figure 1. The addition to the right with its connecting hyphen is compatible with the Collegiate Gothic-style library. The addition is set back from the front of the library and uses the same materials and a simplified design that references, but does not copy, the historic building. Photo: David Wakely Photography.

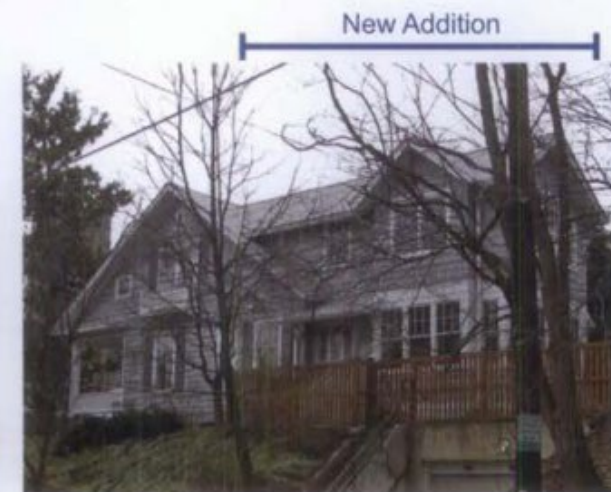
Figure 18. The expansion of a one- and one-half story historic bungalow (left) with a large two-story rear addition (right) has greatly altered and obscured its distinctive shape and form.

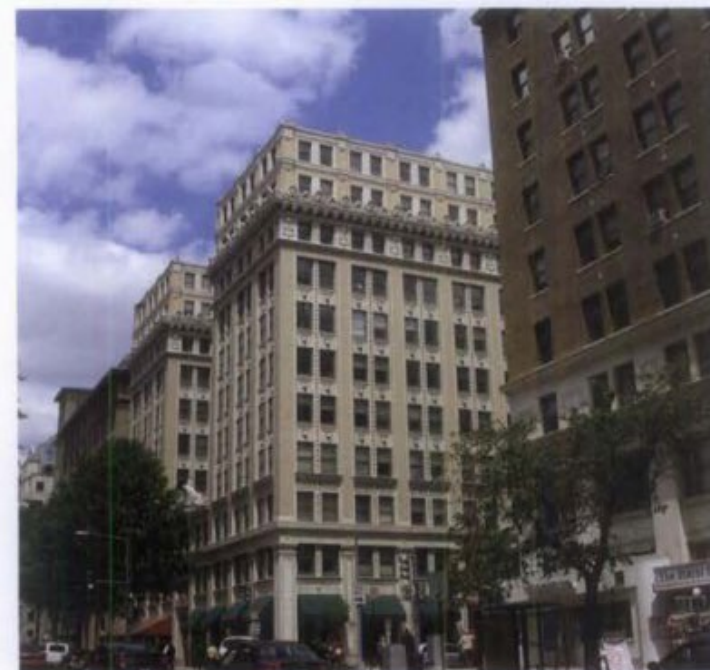
Figure 19. The upper two floors of this early-20th century office building were part of the original design, but were not built. During rehabilitation, the two stories were finally constructed. This treatment does not meet the Standards because the addition has given the building an appearance it never had historically.

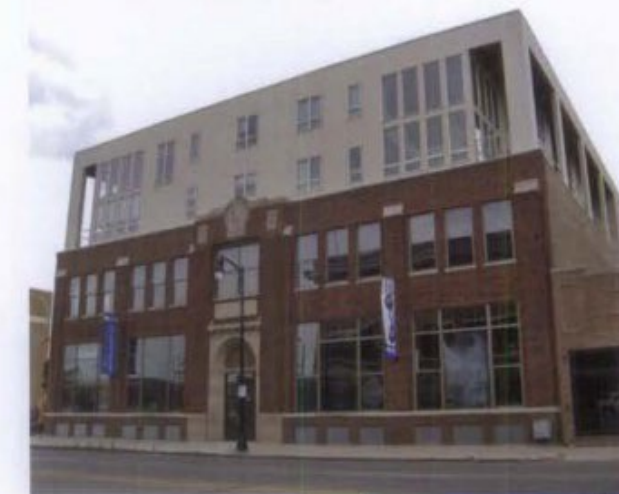
Figure 20. The height, as well as the design, of these two-story rooftop additions overwhelms the two-story and the one-story, low-rise historic buildings.

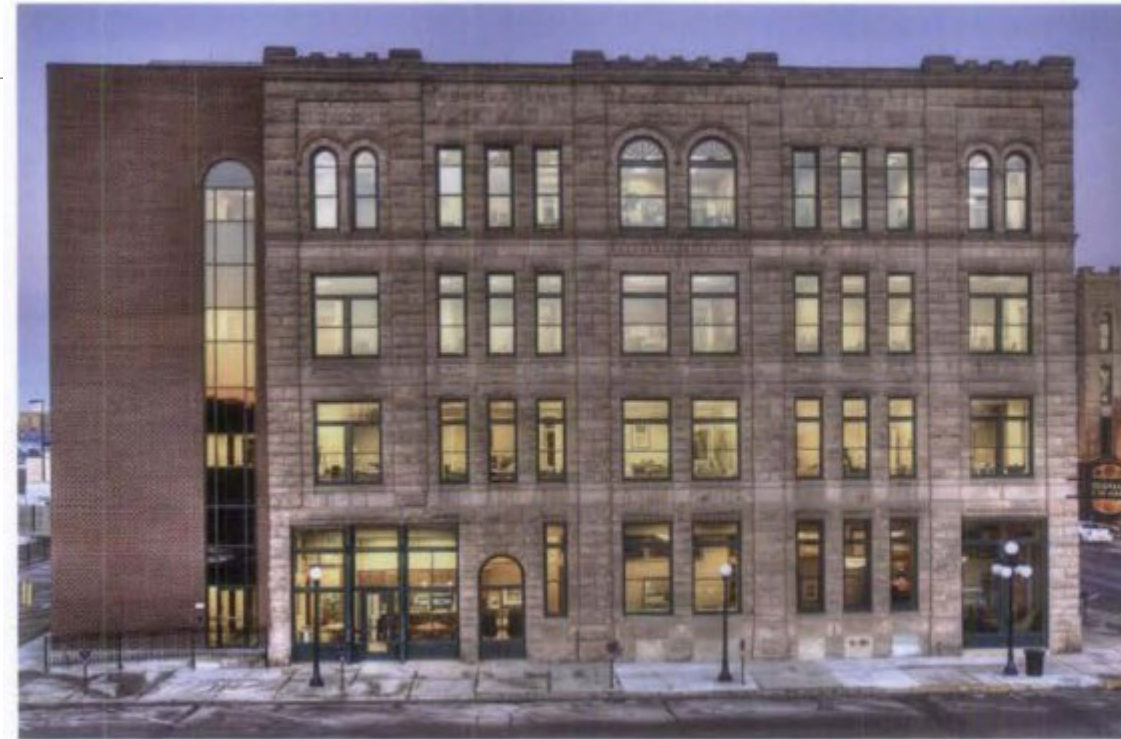
Figure 27. Although the new brick stair/elevator tower (left) is not visible from the front (right), it is on a prominent side elevation of this 1890 stone bank. The compatible addition is set back and does not compete with the historic building. Photos: Chadd Gossmann, Aurora Photography, LLC.

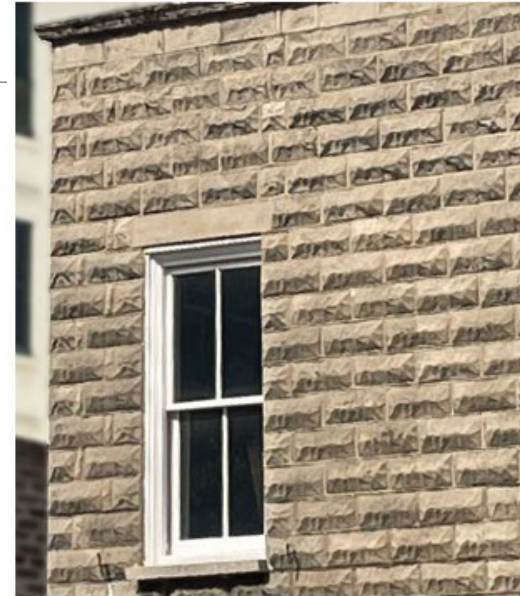
Figure 2a. Casting concrete blocks to mimic quarried stone was a popular late 19th- to mid 20th-century technique. Concrete masonry units could be completed by local craftsmen, saving time and shipping costs. Photo: John Sandor, NPS.

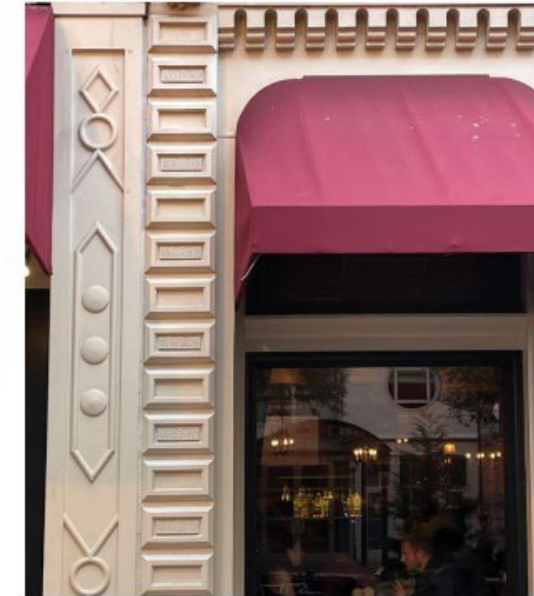
Figure 2b. The 19th century also produced a variety of metal products used to imitate other materials. Across the country, cast iron was used in storefronts to imitate stone. Photo: John Sandor, NPS.

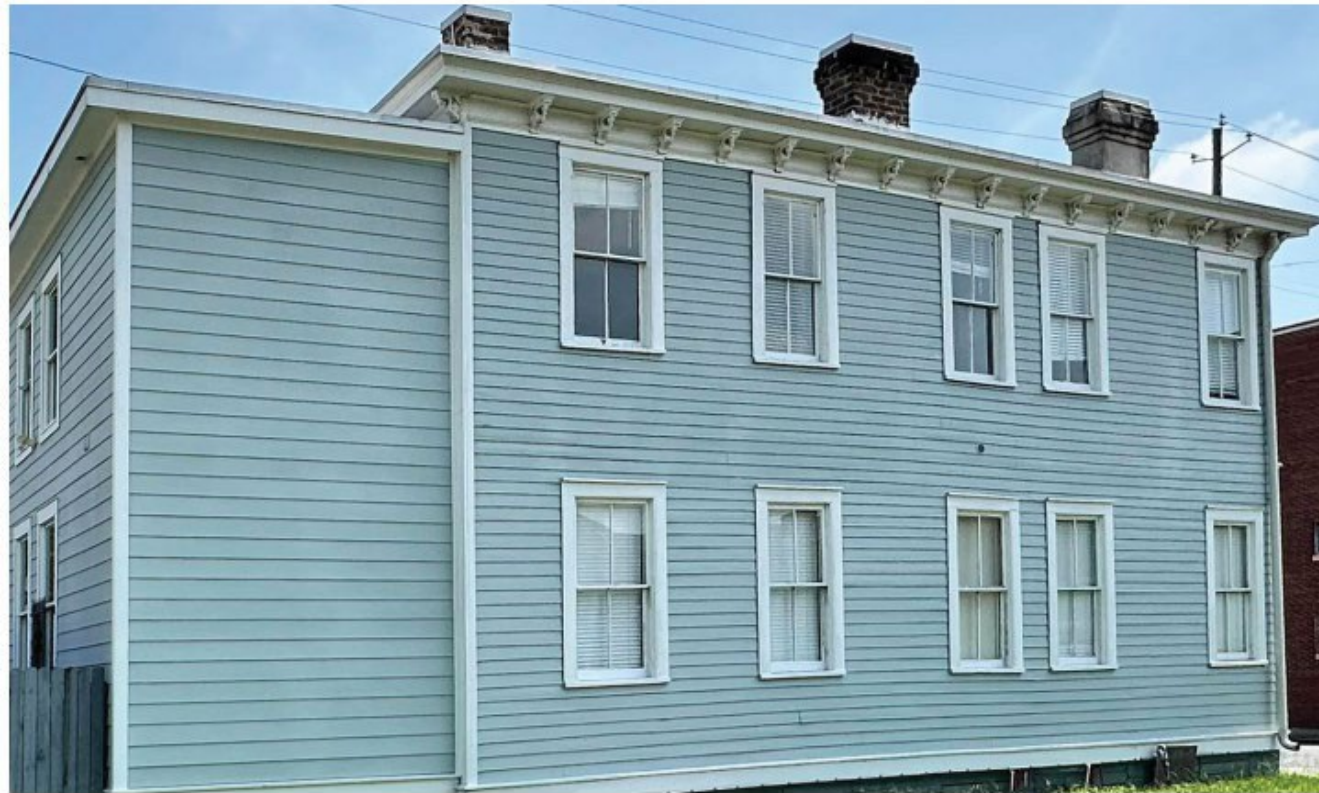
Figure 7. A new addition replaced non-historic construction on the rear elevation of this building. Fiber cement gives the addition a compatible appearance without replicating the exposure for thickness of the historic siding. Photo: Ward Architecture + Preservation.

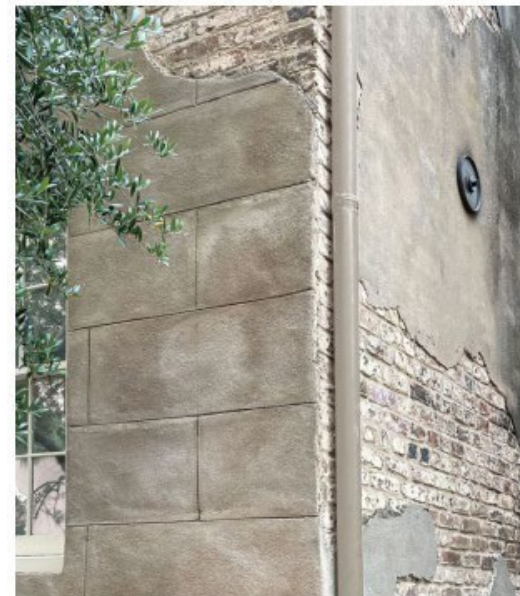
Figure 2c. Stucco has been used to imitate a number of building materials for many centuries. Seen here, stucco was applied to a brick structure and scored to represent a stone façade. Photo: John Sandor, NPS.

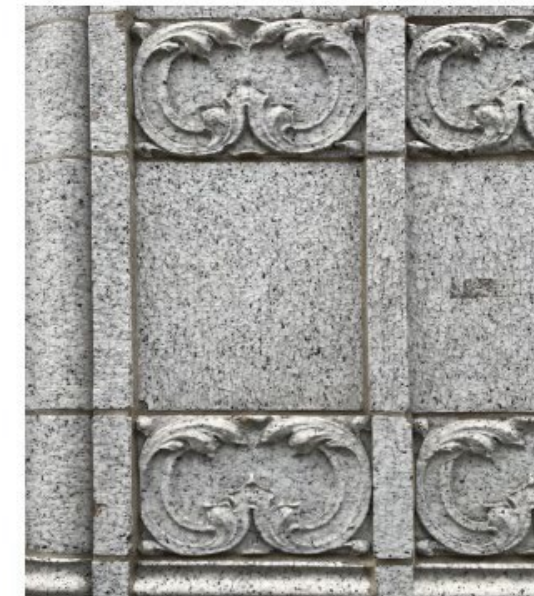
Figure 2d. Terra cotta gained popularity in the late 19th century as a cheap and lightweight alternative to stone. Glazing techniques allowed the blocks to imitate a variety of natural stone materials. Photo: John Sandor, NPS.

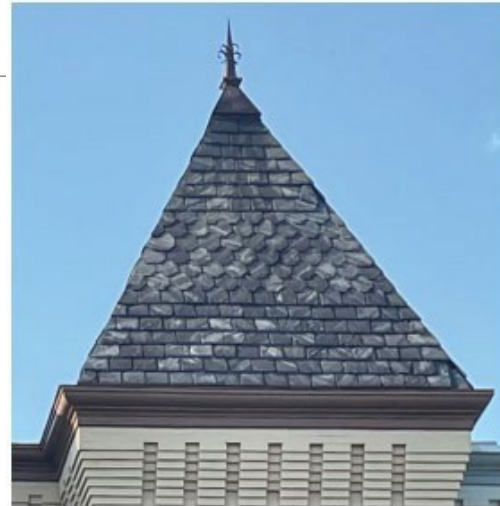
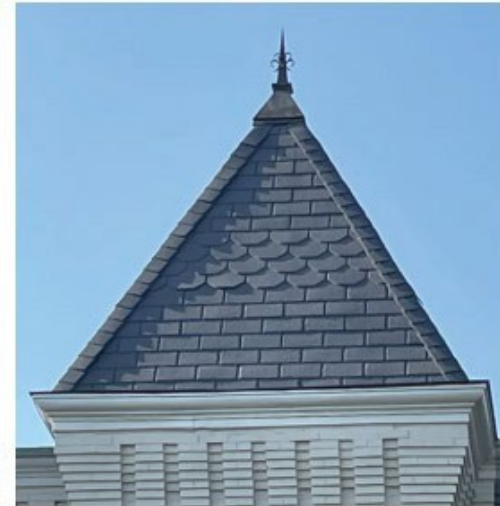
Figure 10. Polymer slates offer a choice of shapes but not sizes, limiting their ability to achieve a good visual match for some historic slate. With the size of the polymer slates (right) being nearly twice that of the historic slates (left), the scale of the entire feature is incompatibly altered. The molded edges of this material, which contribute to its ability to replicate slate, would be lost if each shingle was resized by cutting. Photo: John Sandor, NPS.

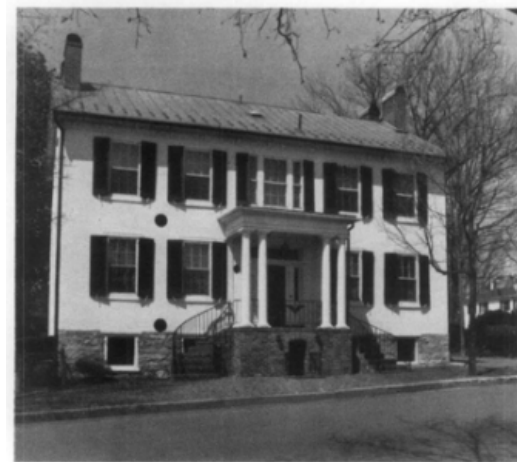
Fig. 1. These two houses in a residential section of Winchester, Virginia, illustrate the continuing popularity of stucco (a) from this early 19th century, Federal style house on the left, (b) to the English Cotswold style cottage that was built across the street in the 1930's. Photos: Anne Grimmer.

Stucco has been used since ancient times. Still widely used throughout the world, it is one of the most common of traditional building materials (Fig. 1). Up until

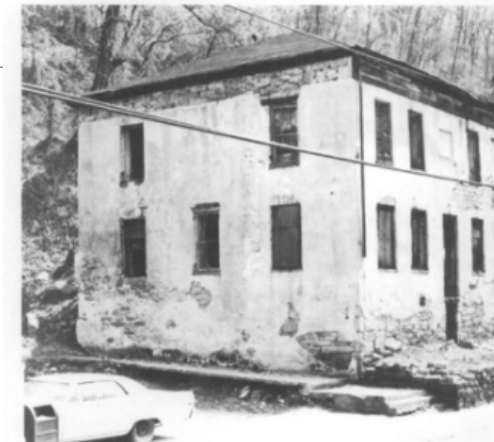
Fig. 7. Patches of stucco have fallen off this derelict 19th century structure exposing the rough-cut local stone substrate. The missing wood entablature on the side and the rough wood lintel now exposed above a second-floor window, offer clues that the building was stuccoed originally. Photo: National Park Service Files.

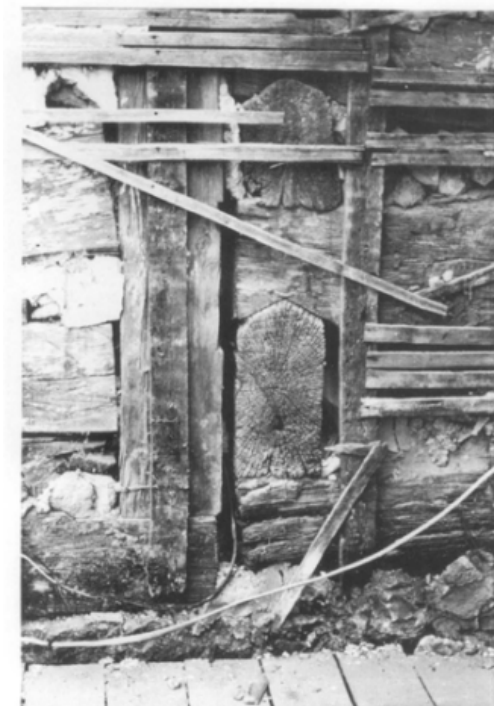
Fig. 8. Removal of deteriorated stucco in preparation for stucco repair on this late-18th century log house in Middleway, West Virginia, reveals that the stucco was applied to hand-riven wood lath nailed over vertical wood strips attached to the logs. Photo: Anne Grimmer.

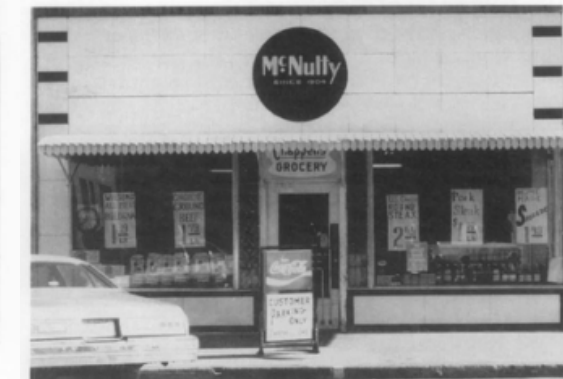
7. In the 1930s and 1940s, signs built into storefronts became popular. This example is from Guthrie, Oklahoma. Photo: H. Ward Jandl.

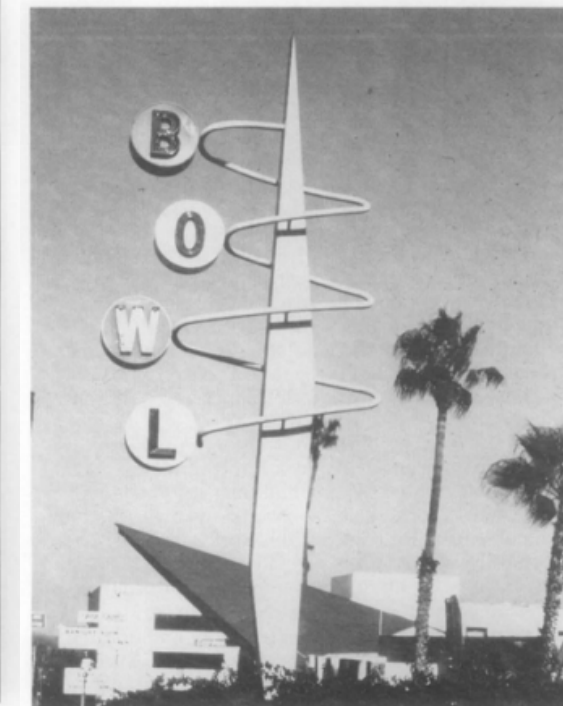
8. In the late 1950s and early 1960s, the country turned its attention to outer space. Wings, fins, and satellite shapes appeared, as in this example in Long Beach, California. Photo: Peter Phillips.
