# CIFUENTES STUDIO

## FRUTILANDIA SUBSTANTIAL CONFORMANCE IMPROVEMENT PERMIT

May 24<sup>th</sup>, 2021

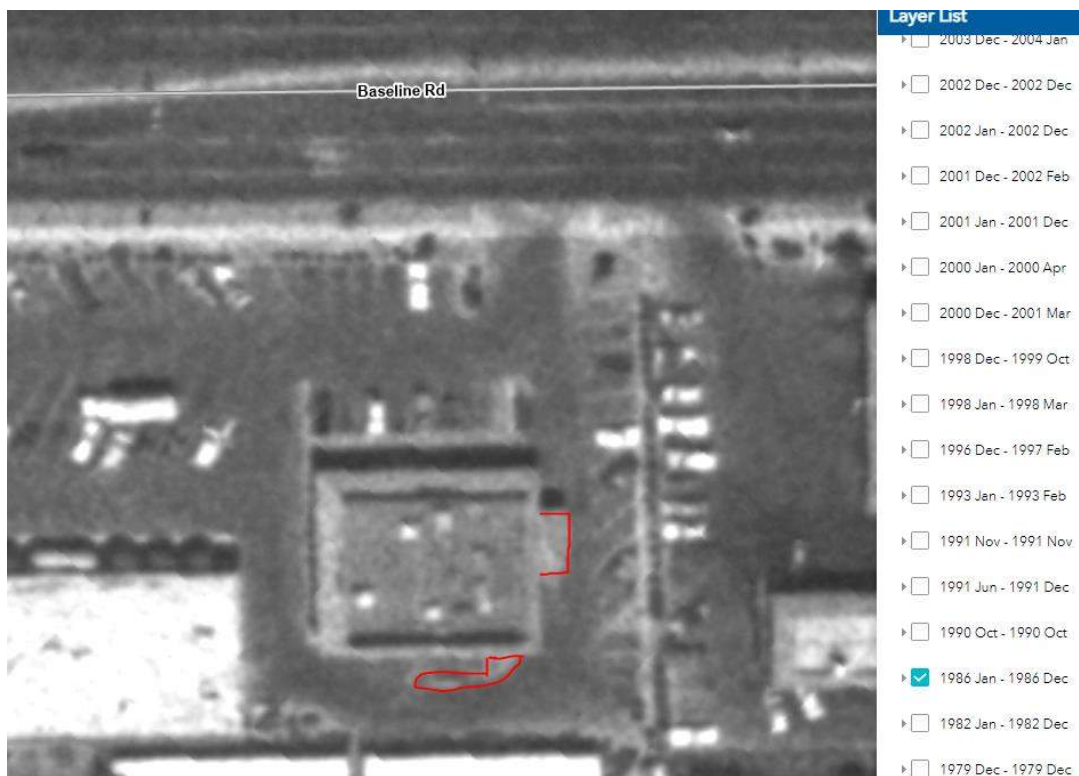
As one can see the building was situated on site with the intention of having a drive-through as it was located for that use of the east part of the building. Upon further research through the Maricopa County Historic Aerials from 1986 (the year the building was completed) it is visible that the service area and the proposed drive-through as designed and approved in the site plan were indeed built as part of the Grandy's project.

Figure 2 - 1986 Maricopa Aerial (Grandy's)

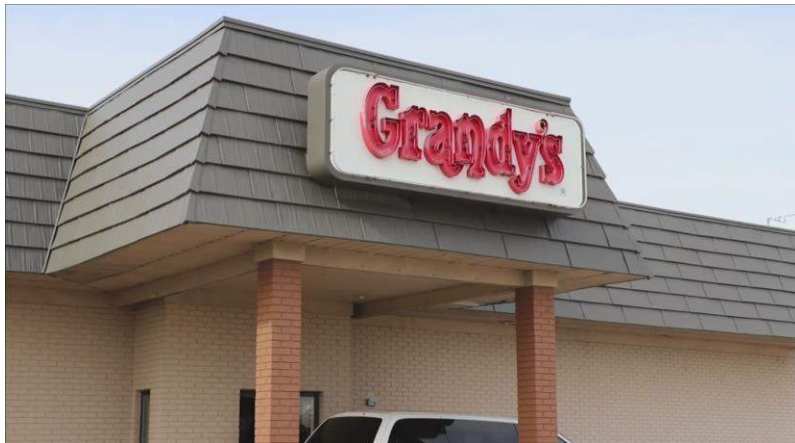
Once we located this historic aerial, we did more research into the Grandy's concept from the 1980's and indeed found that their restaurants usually featured a small drive-through canopy with two column piers as is visible in Fig. 3 and 4.

Figure 3 - Grandys 80's Drive-Thru

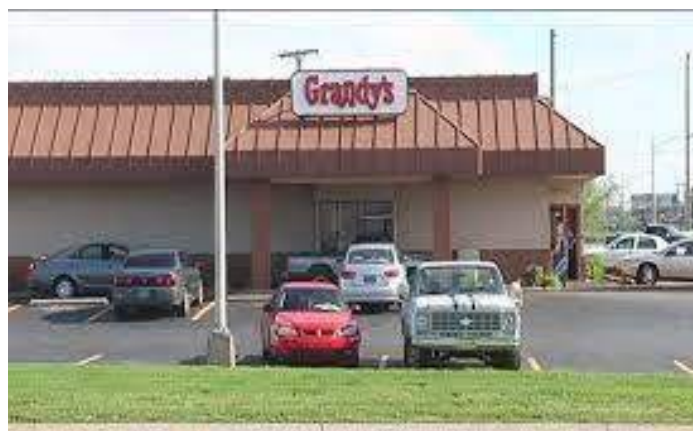
Figure 4 - Grandy's 80's Drive-Thru

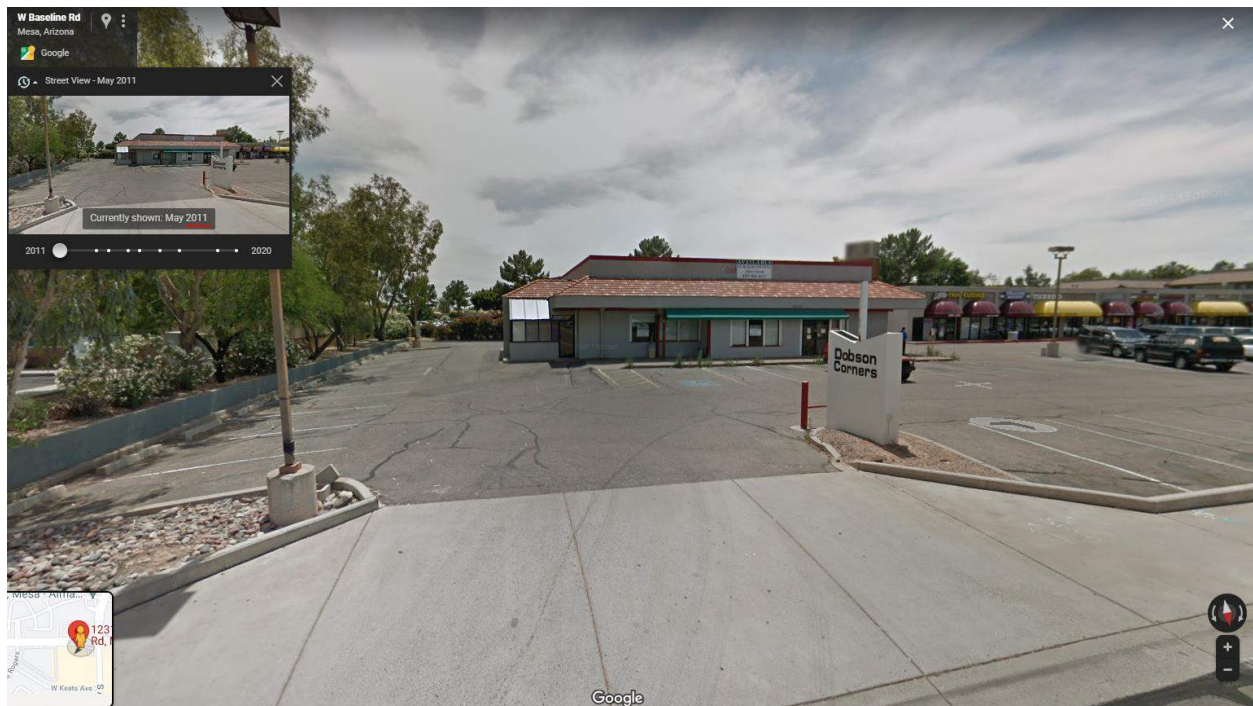
This bring us to today, the current building has sat in the prime intersection of Alma School and Baseline Road, vacant and dilapidated for over 10 years, as you can see in this Google Street image from 2011 where the building was already showing signs of disrepair and aging.

Figure 6 - 2011 Google Street View

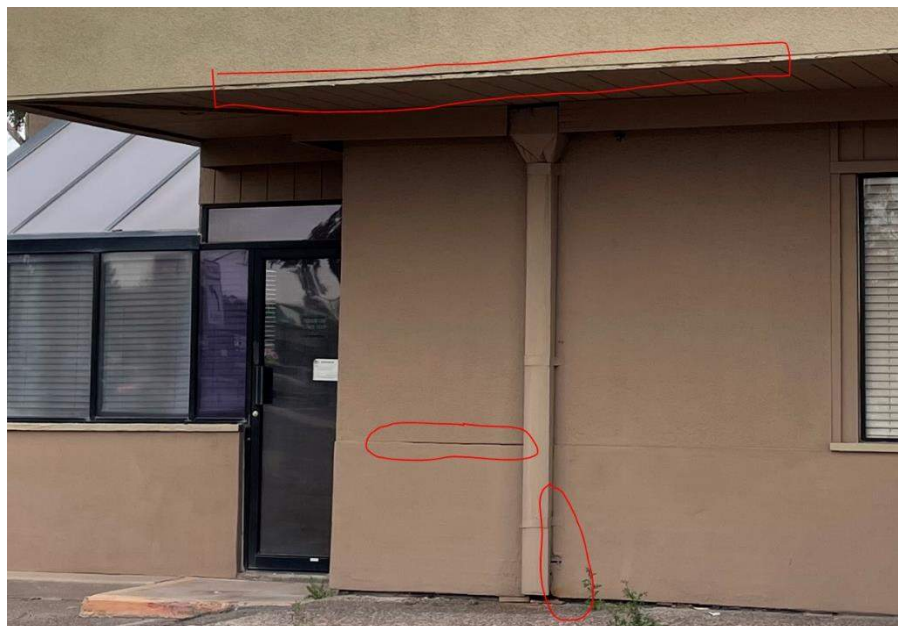
As outlined in the attachments below, the building has graffiti damage, excessive buildup of trash from transient users, efflorescence caused by the leaching of the coping cap detail above, various broken clay shingles throughout, and excessively damage to the existing stucco finish and the underside of the soffit.

In my professional opinion these conditions can not readily be remediated by just a patch job of the stucco and the condition of the building aesthetically has become a deterrent to both local business owner and the adjacent office business park that is struggling to fill it's leasable office square footage.

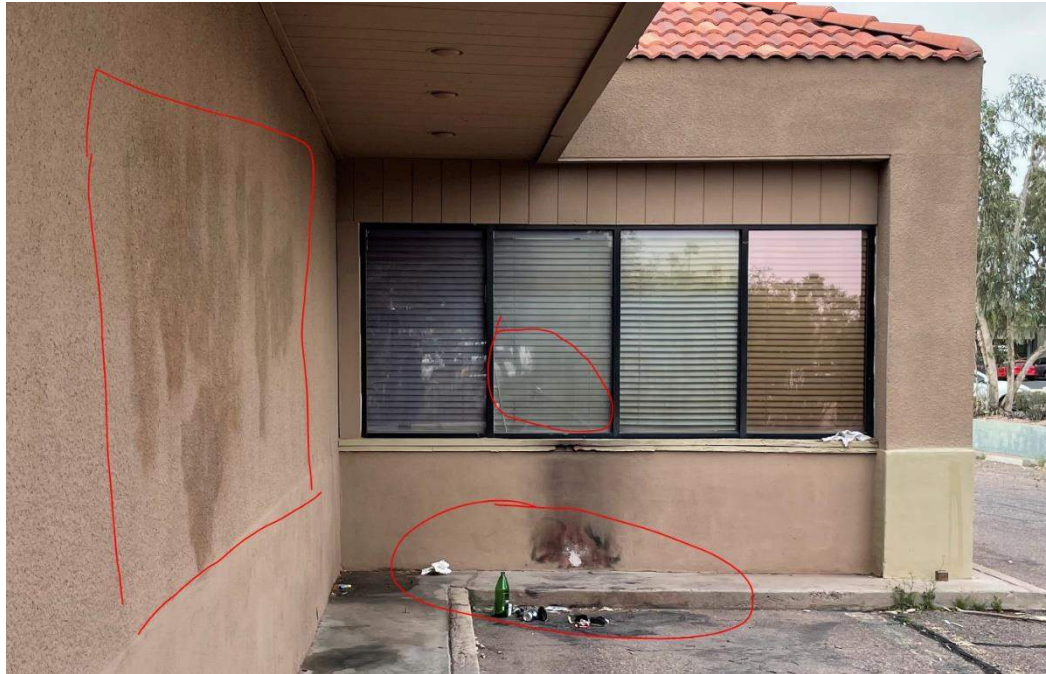
**Figure 8 - Fire damage, Trash, Broken glass, Graffiti on the back side**
