**LAND SUBSIDENCE & EARTH FISSURE EVALUATION  
TASK 1 & TASK 2 EARTH FISSURE EXPLORATION PROGRAM.**

**SUNVALLEY RANCH, TRACT L, APN 218-16-023  
SWC E. BILLINGS STREET & N. SOSSAMAN ROAD  
MESA, MARICOPA COUNTY, ARIZONA**

**GCI Project No. 2017-144**

January 29, 2018  
Revised: April 7, 2018

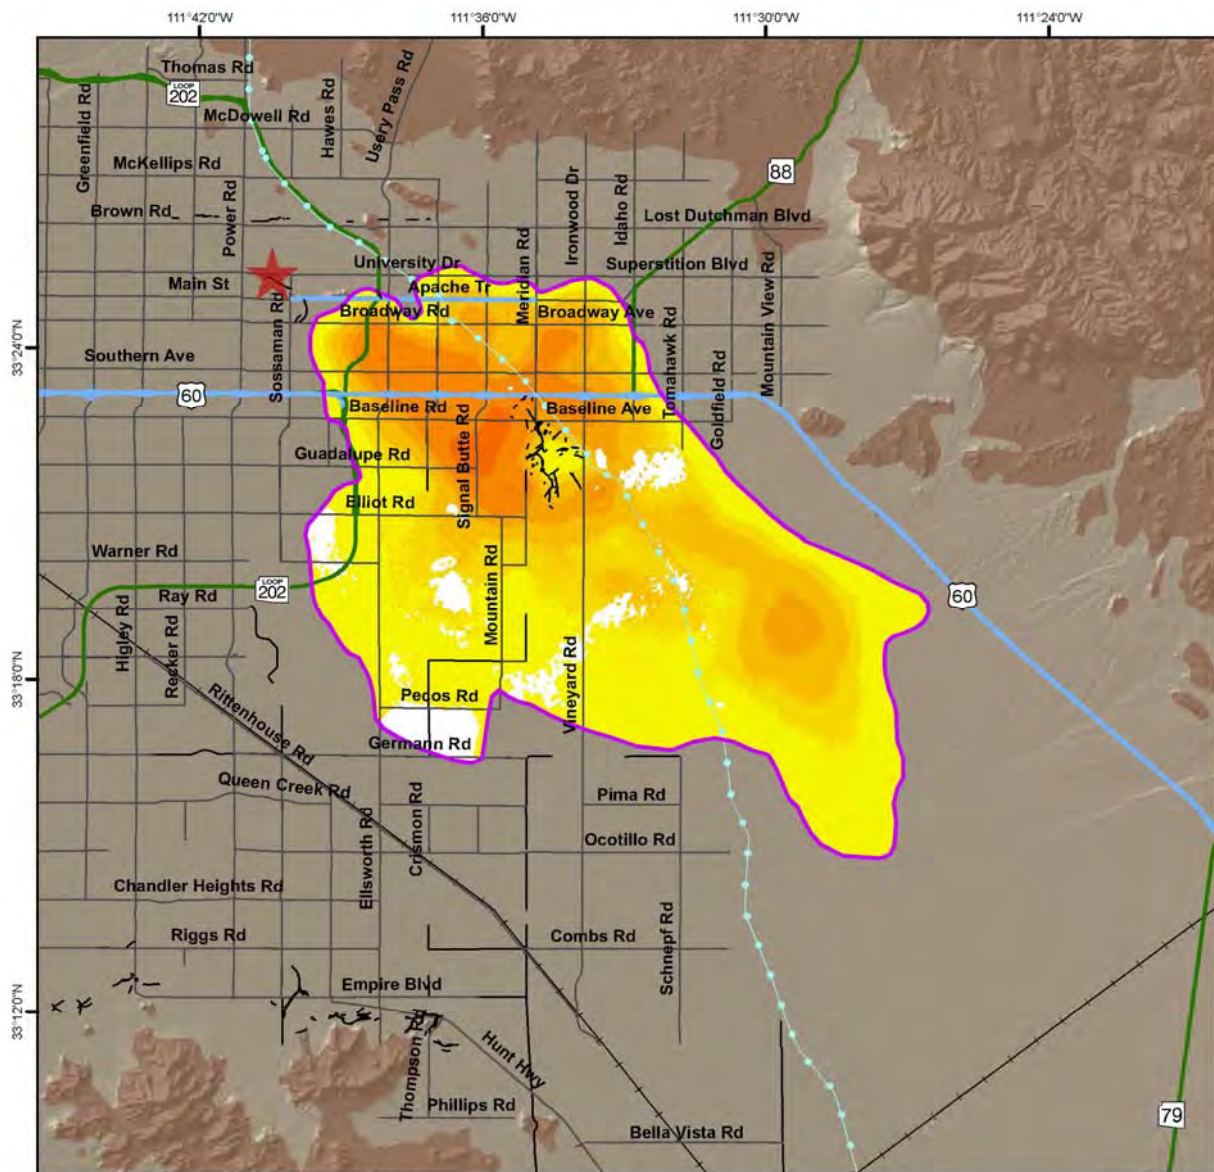
- 2.1** The study area borders an area of ongoing land subsidence and earth fissuring. Research data indicates that land subsidence and related earth fissuring have been active for more than 40 years. Recent InSAR data and well records suggest subsidence is ongoing in the project vicinity.

Total Land Subsidence in the Hawk Rock Area, Maricopa and Pinal Counties  
Based on Radarsat-2 Satellite Interferometric Synthetic Aperture Radar (InSAR) Data  
Time Period of Analysis: 6.9 Years 05/15/2010 To 03/15/2017
