#### EXISTING ELEVATIONS 117, 119 (SCOPE LINES)

#### NEW ELEVATION 117, 119

# DEMOLITION | 117, 119

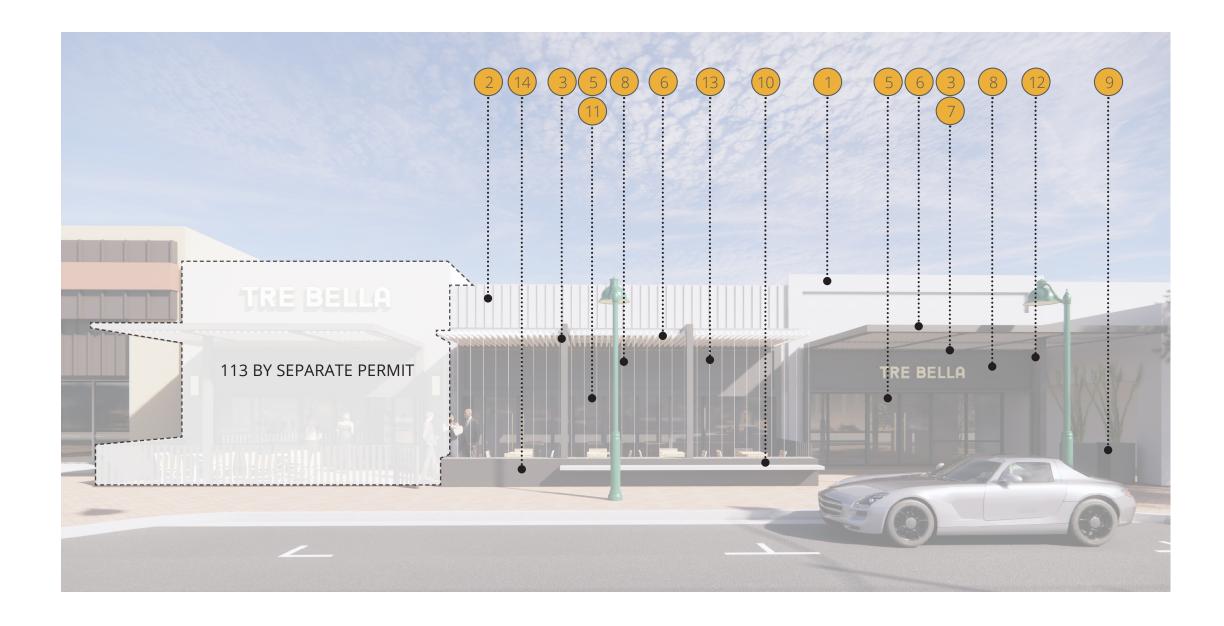
#### PERSPECTIVE (MATERIALITY CALLOUTS) | 117, 119

- REPAIR AND REPAINT STUCCO

TYP. ALL
- 2. EXPOSE EXISTING CORRUGATIONS
- 3. ~6X6 TUBE STEEL FRAME
- 4. WALL SCONCE(S)
- 5. NEW STOREFRONT SYSTEM
- 6. STEEL SHADE CANOPY SYSTEM
  (~6X6 STEEL TUBE WITH LIGHT
  GAUGE LOUVERS)
- 7. "ROPE LIGHT" OR SIMILAR

AROUND INSIDE OF FRAME TYP.
- 8. METAL PANEL INSIDE FRAME
- 9. METAL PLANTER BOXES
- 10.BENCH
- 11. SLIDING GLASS STOREFRONT
  SYSTEM
- 12.NEW STEEL COLUMNS TO

UTILIZE EXISTING FOOTINGS IF

POSSIBLE
- 13. STEEL CABLES
- 14. STEEL PLANTER BOX
