MESA

HISTORIC PRESERVATION DESIGN GUIDELINES

MESA'S HISTORIC
RESOURCES

PREPARED BY
THE CITY OF
MESA

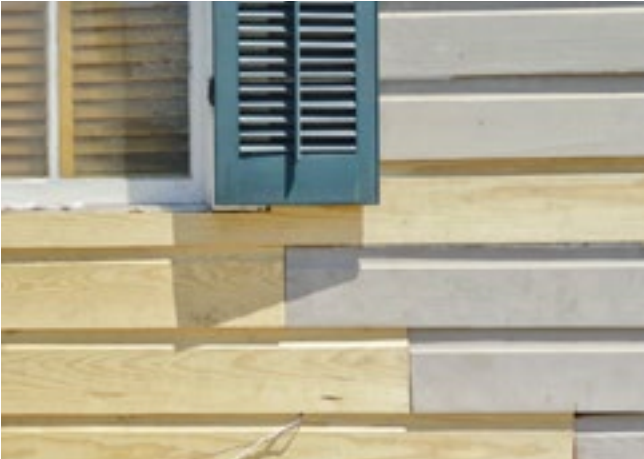
The Dutchman repair method allows for the installation of new wood while preserving the historic wood.

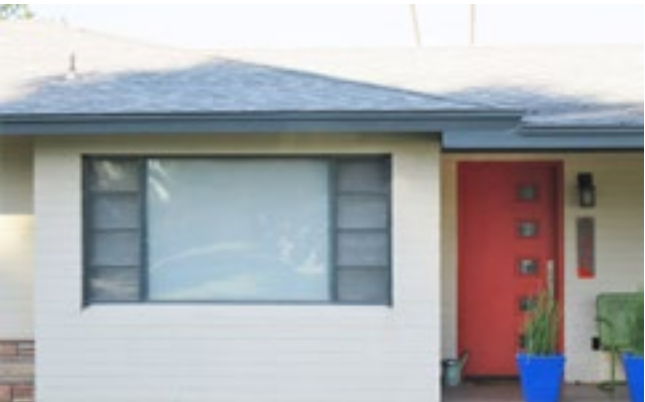
146 N. Fraser Dr. West (Original and historic doors help to convey the character of the style of the house)

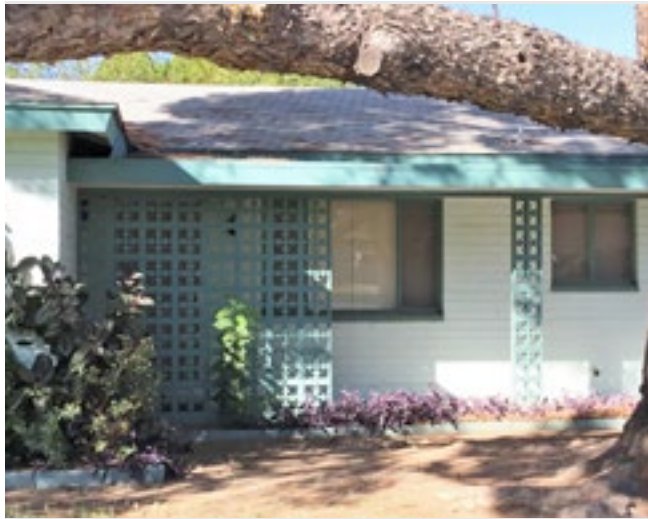
234 N. Fraser Dr. (The breezeblock elements on this porch contribute to the character of the house)

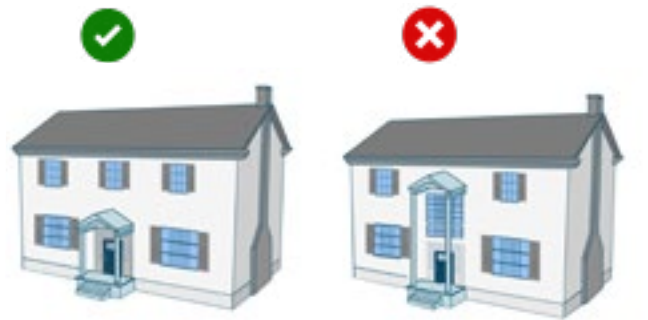
Figure 3.6 Porch Scale and Form

Porches should be compatible in size and scale with the primary structure
