Design Review Board

DRB24-00524 202 RV Valet Storage Expansion

Design Review for an approximately 58,845 square foot expansion of a Boat and Recreational Vehicle Storage Facility

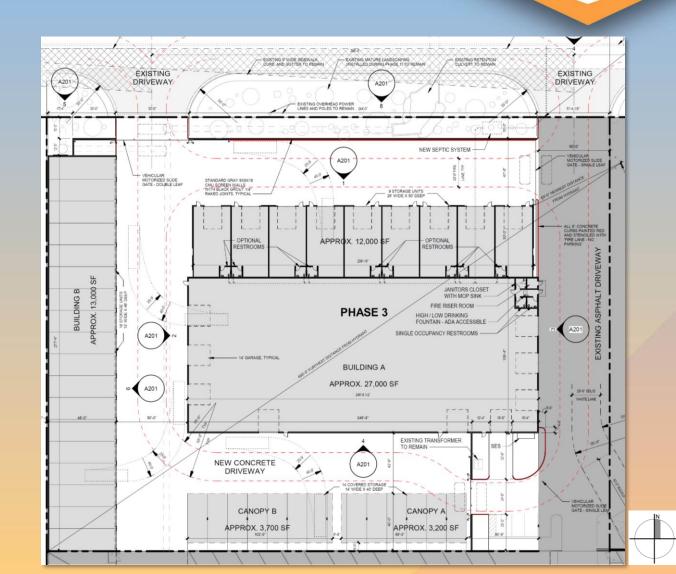
Site Plan

- Four RV and Boat Storage buildings
- Range from 3,200
 square feet to 27,000
 square feet
- 58,845 total building square footage

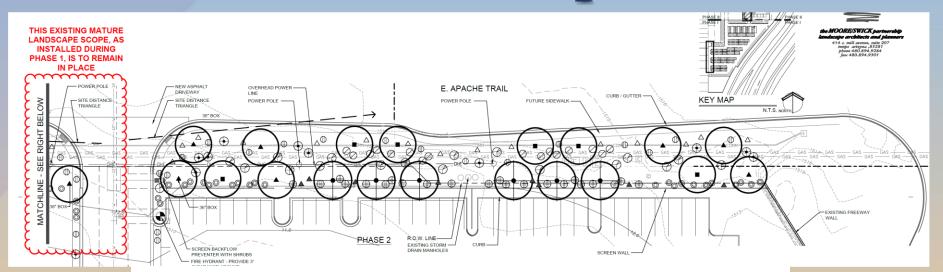
Landscape Plan

THIS EXISTING MATURE LANDSCAPE SCOPE. AS INSTALLED DURING PHASE 1, IS TO REMAIN IN PLACE

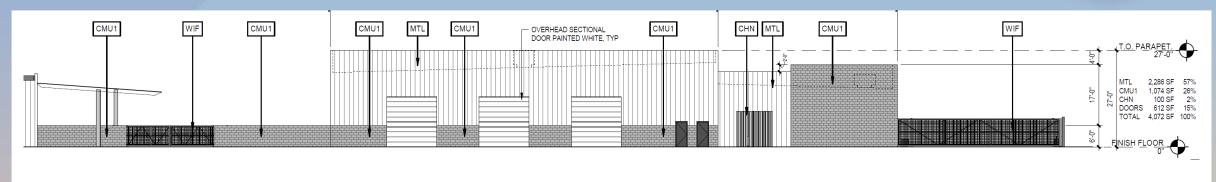
3 BUILDING A - EAST ELEVATION

CMU1 MTL CHN CMU1 OVERHEAD SECTIONAL CMU1 MTL CMU1 DOOR PAINTED WHITE, TYP
