Date: 06.20.22

World Deliverance Outreach Ministries Project Narrative

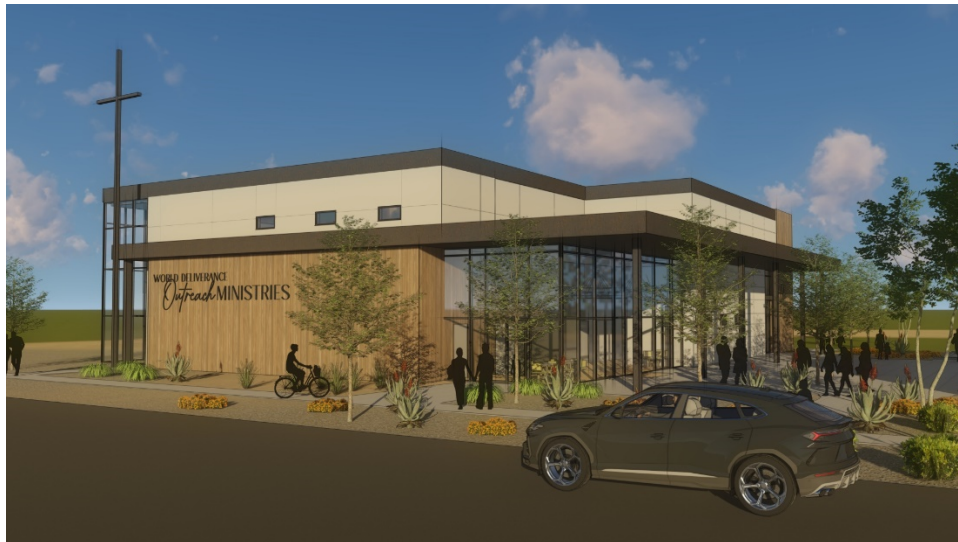
The design of World Deliverance Outreach Ministries is warm and modern. The linear charcoal bands direct the eye to a cross that anchors the street side façade. Glass is used to create a welcome and transparent lobby. We use a variety of building materials including A Warm Wood Tile, EIFS with decorative reveals in cream and warm greys, and expansive glass. Each elevation provides no more than 50% of any single material. In lieu of a consistent recognizable "base" on the building (a more traditional look) we alternately comply by grouping the enhanced materials into masses that provide depth and character for each façade. These vertical planes and masses are more befitting of the modern character of the design. The upgraded materials include colored and textured wood look tile and crisp reflective glazing. We have enhanced the top of the building with a wide metal cap to create dynamic lines that direct the eye to the cross. Mullion and reveal patterns are used on every façade to create rhythm and order.

Elevations Alternate Compliance to Recognizable Base:
