BUILDING 1, 2, 3 & 4 SECTION

BUILDING 5 & 7 SECTION

## A5.1

TAILWINDS PHASE 1  
8133 EAST PECOS ROAD  
MESA, ARIZONA 85212

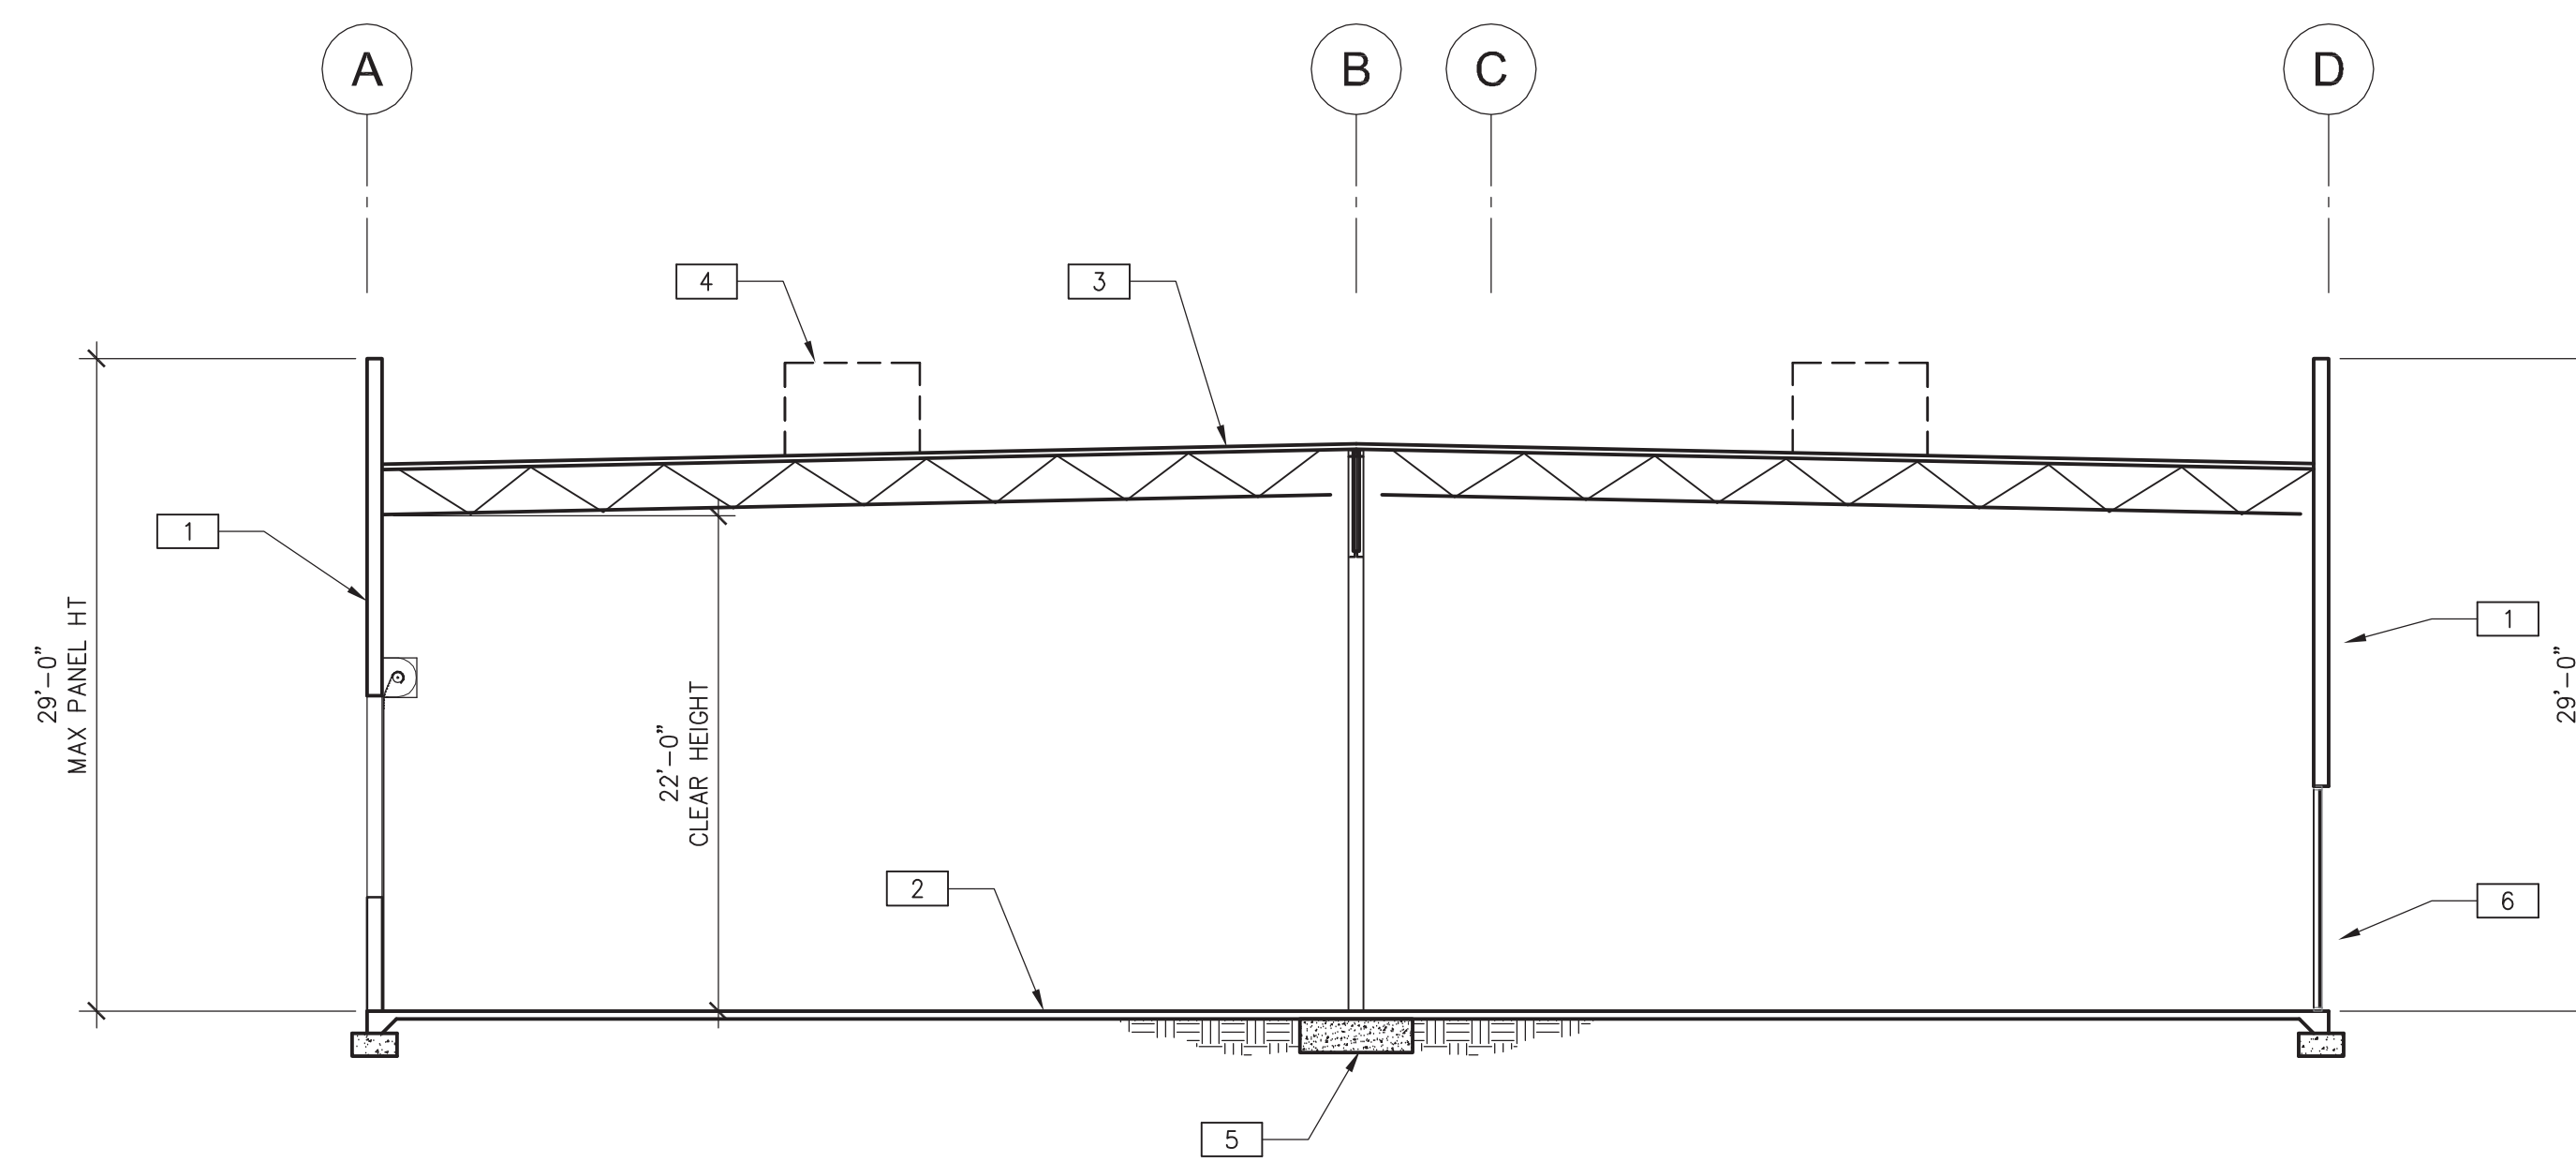
- 1 CONCRETE WALL, PAINTED.
- 2 CONCRETE SLAB.
- 3 SINGLE-PLY ROOFING OVER RIGID INSULATION OVER WOOD DECK
- 4 FULLY SCREENED MECHANICAL UNIT BEYOND
- 5 CONCRETE FOOTING.
- 6 ALUMINUM STOREFRONT SYSTEM
