## MEMORANDUM

**To:** Planning and Zoning Board  
**Through:** Nana Appiah, Planning Director  
**From:** Cassidy Welch, Planner II  
**Date:** October 13, 2021  
**Subject:** ZON20-00840 – Westmount Estates

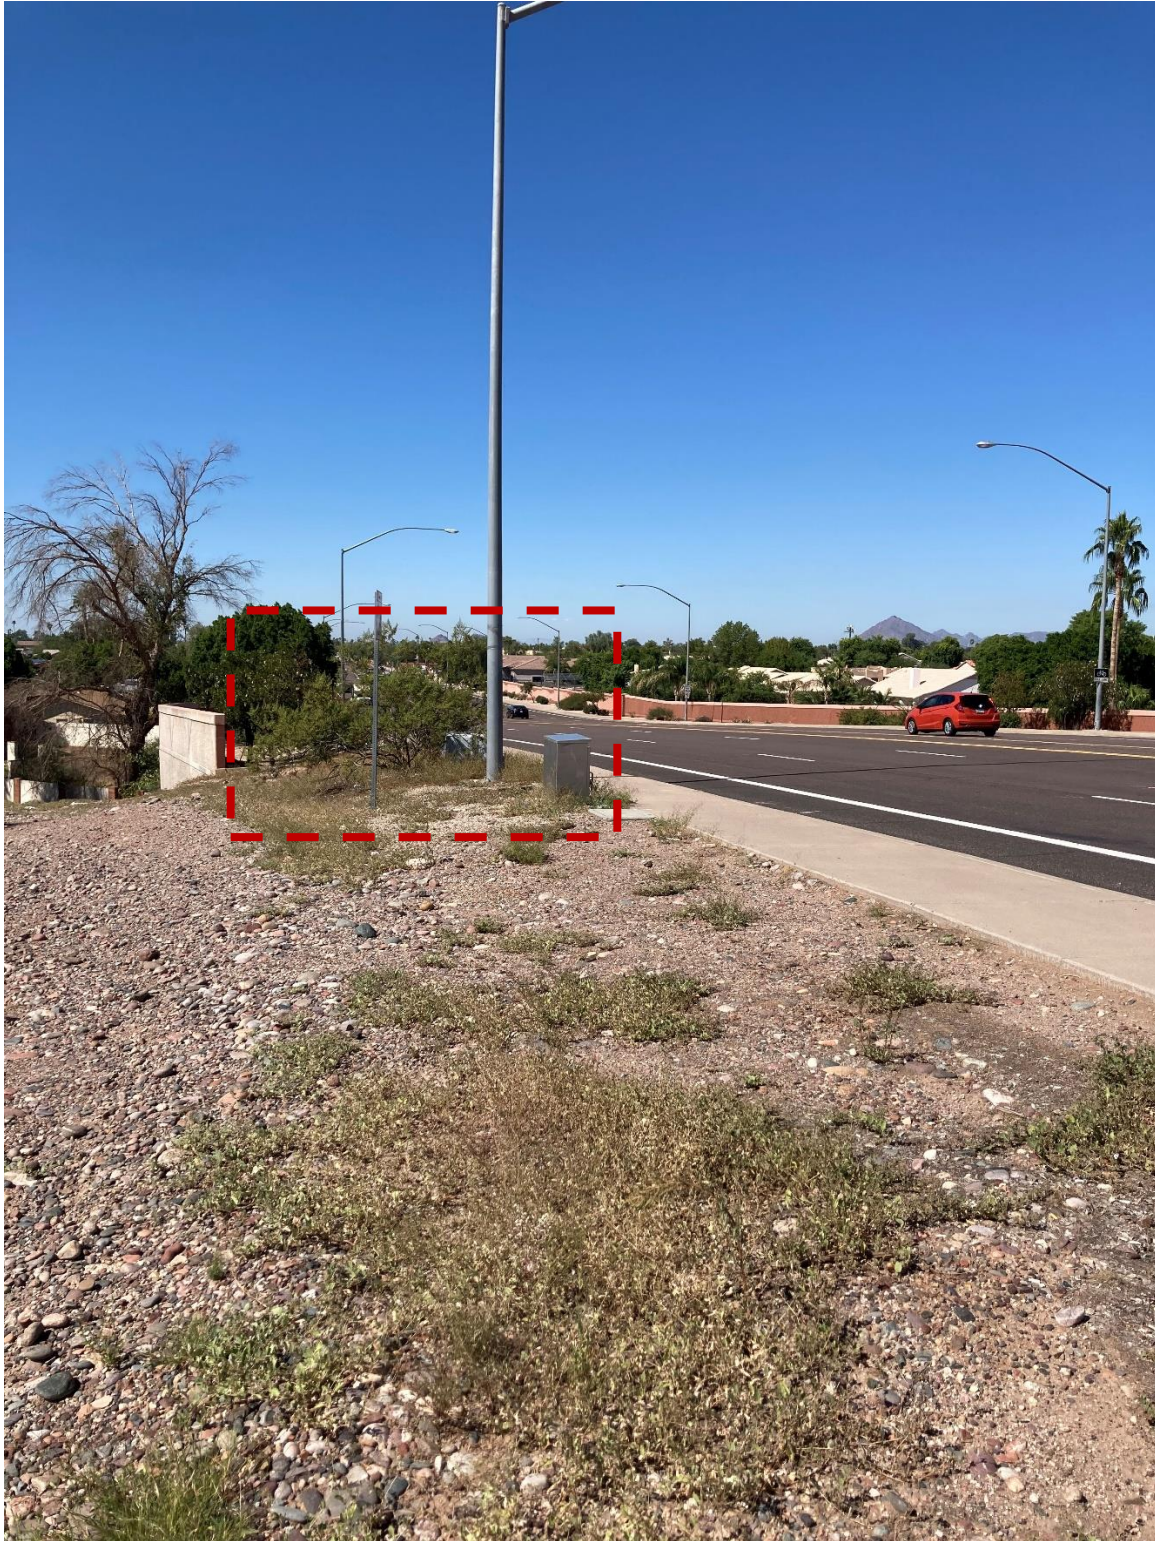
Exhibit 1: Photo looking West from approximate driveway location

*With removal of shrub, vehicles will have clear visibility to Horne, approximately 1/4 mile to the west of the subject site.*

Planning staff conducted a site visit which included photos taken from the point of view of a driver's side window (See Exhibits below). Upon evaluation, staff found the potential obstructions are at a lower grade than the proposed driveway location and do not exceed the minimum height of 2.5 feet (per the City Design Standards Manual) to be considered a sight obstruction. Staff did, however, find that an overgrown and unmaintained shrub obstructed visibility to the west. Staff would encourage the applicant to remove this overgrown shrub as a part of the permitting and

construction process. In conclusion, with removal of the overgrown shrub, there will sufficient visibility of the oncoming traffic for a vehicle to safely enter McKellips Road heading in either the eastbound or westbound directions.

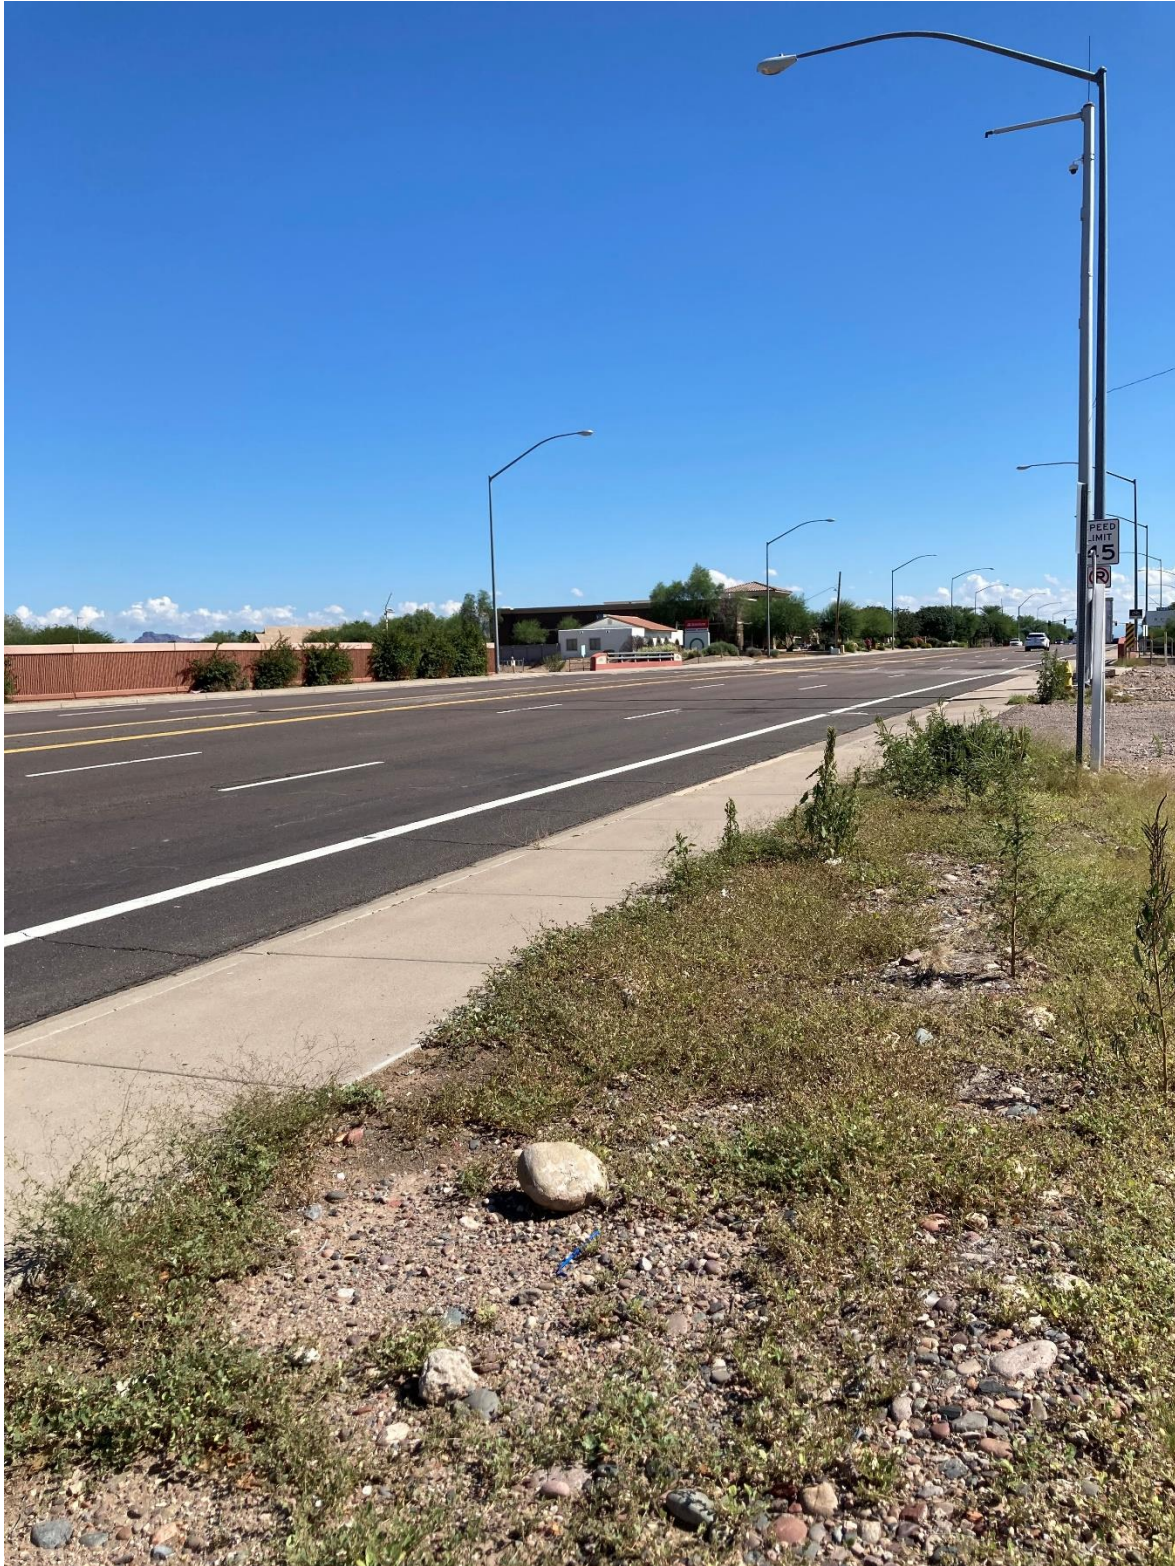
Exhibit 2: Photo looking East from approximate driveway location

*Vehicles have clear visibility to Stapley Drive, approximately 1/4 mile east of the subject site.*
